COPPER BASE ALLOYS

CASTING DEFECTS

COPPER BASE ALLOYS CASTING DEFECTS

Editor: Assistant Prof. Dr. Hikmet ERBIYIK

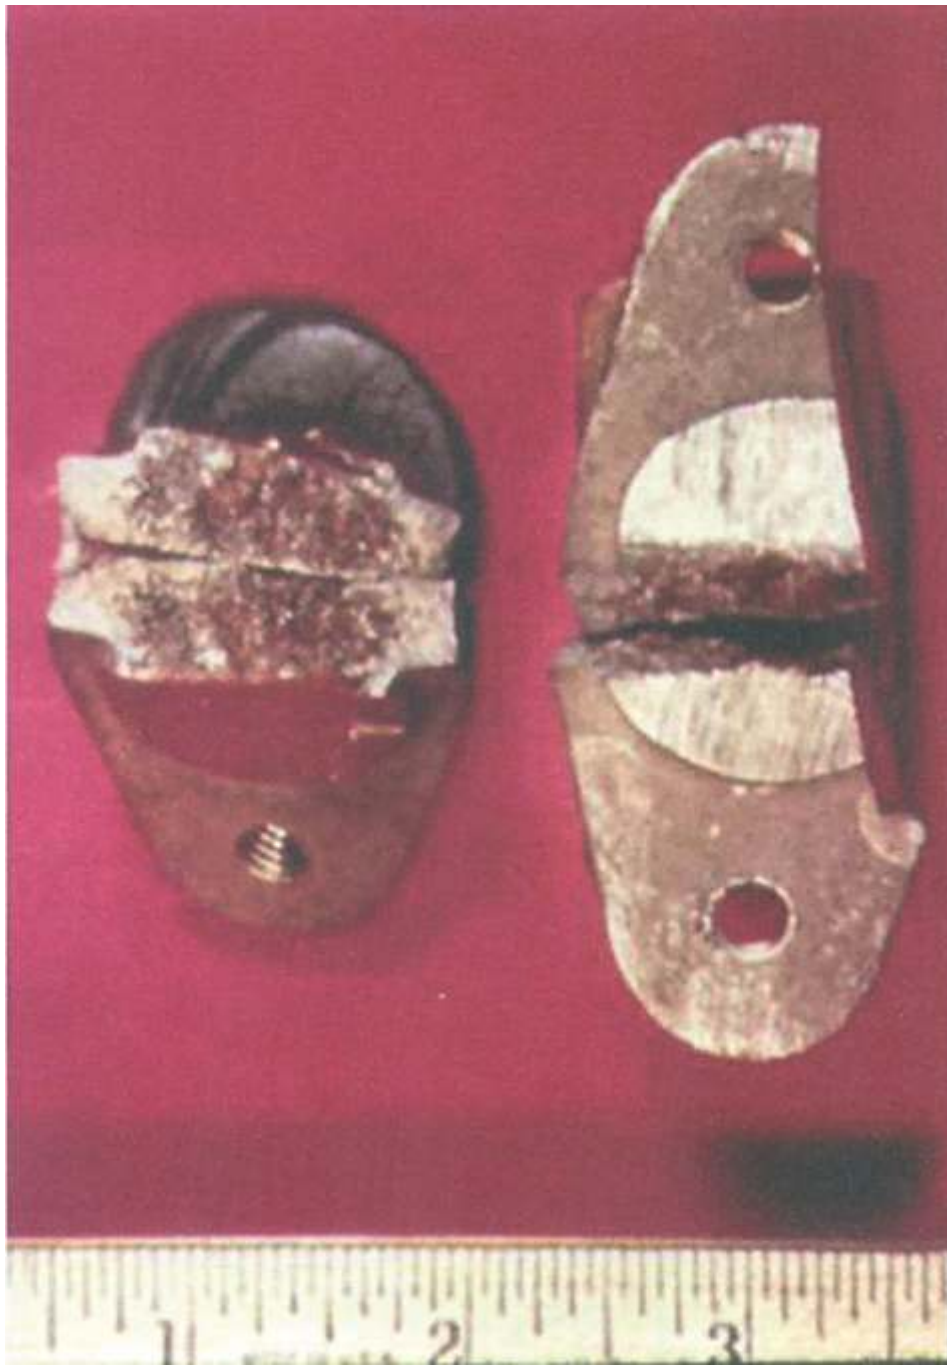
Fig. 1-1. Aluminum in red brass is an impurity that results in casting microstructural weakness prone to cracking.

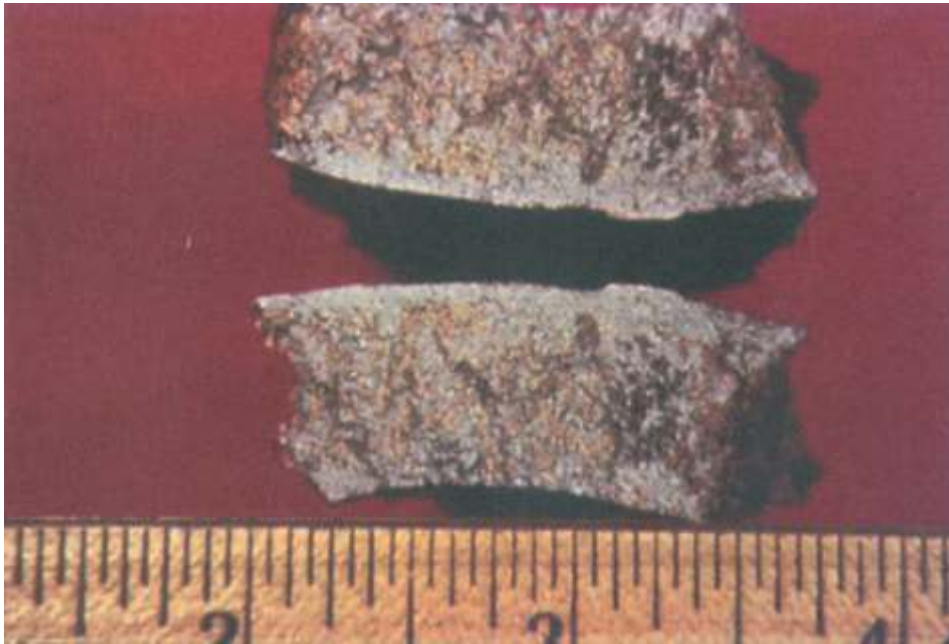
Fig. 1-2. Silicon in red brass is an impurity concentration that results in casting microstructural weakness prone to cracking.

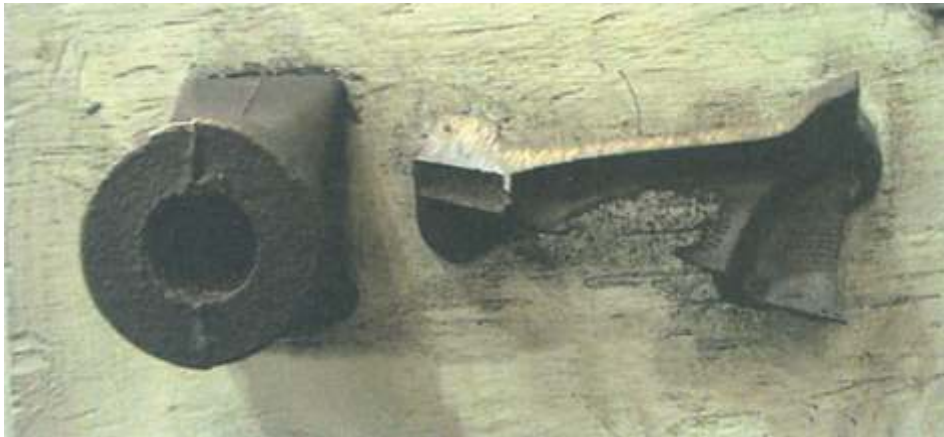
Fig. 1-4. The broken core shows low binder content, poor density and age.

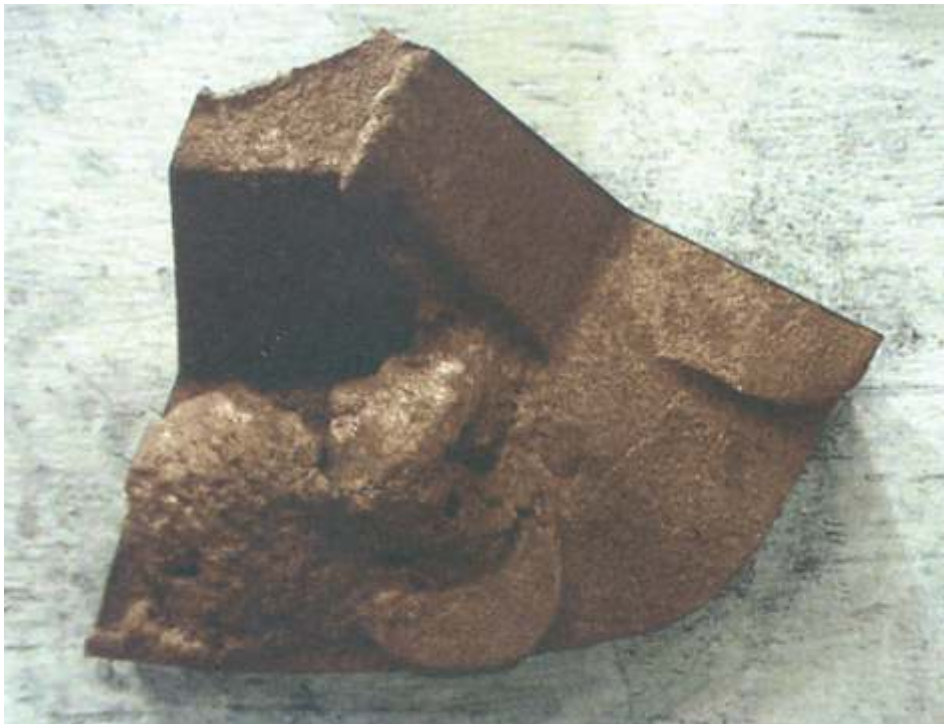
Fig. 1-5. The cracked mold is caused by push up or drop. The drag sand level is not full.

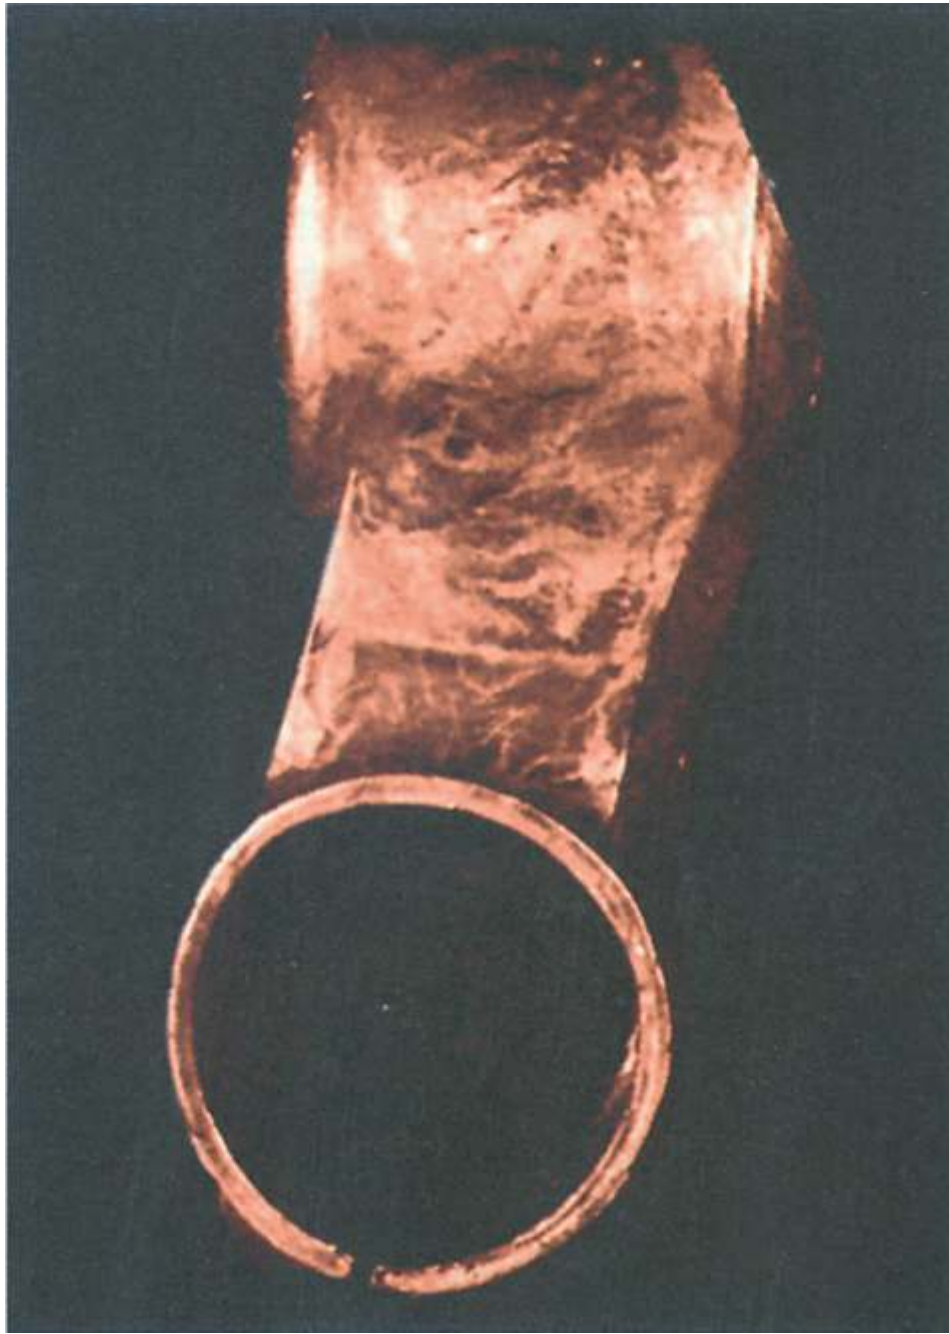
Fig. 2-2. Same casting as in Fig. 2-1 shows flow marks caused by high pouring temperature and turbulent filling of the mold.

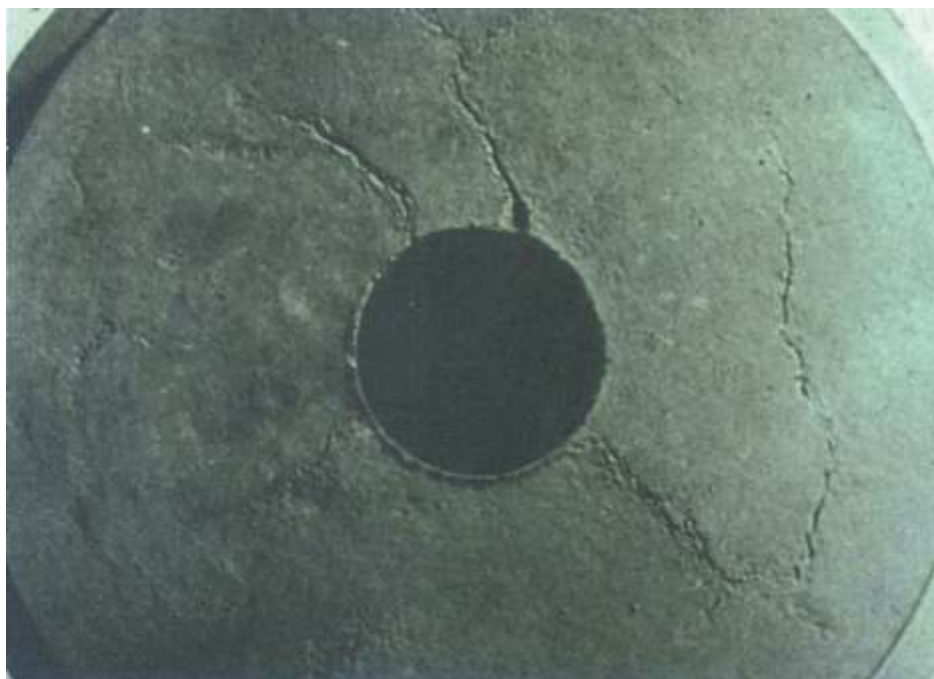
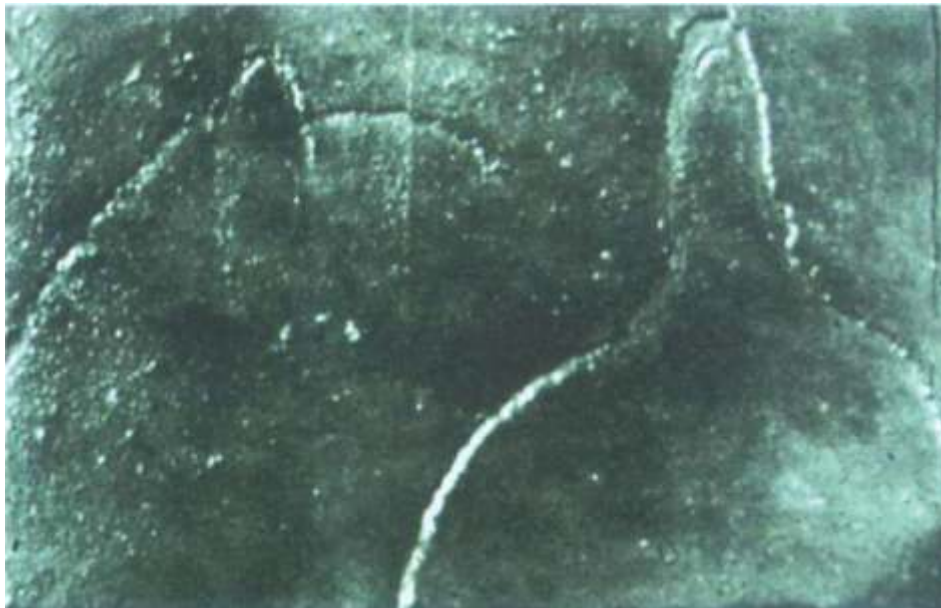
A rattail is a rather shallow irregular groove-type of defect appearing usually on horizontal drag surfaces, and often extending from gate locations. Heat from the flowing metal causes steam formation of the moisture in the green sand at the surface. This causes expansion as the steam escapes and creates a protrusion, resulting in a 'negative' or rivulet as the casting surface solidifies.

Fig. 3-1. Rattail.

Fig. 3-2. Rattail.

Fig. 3-3. Rattail.

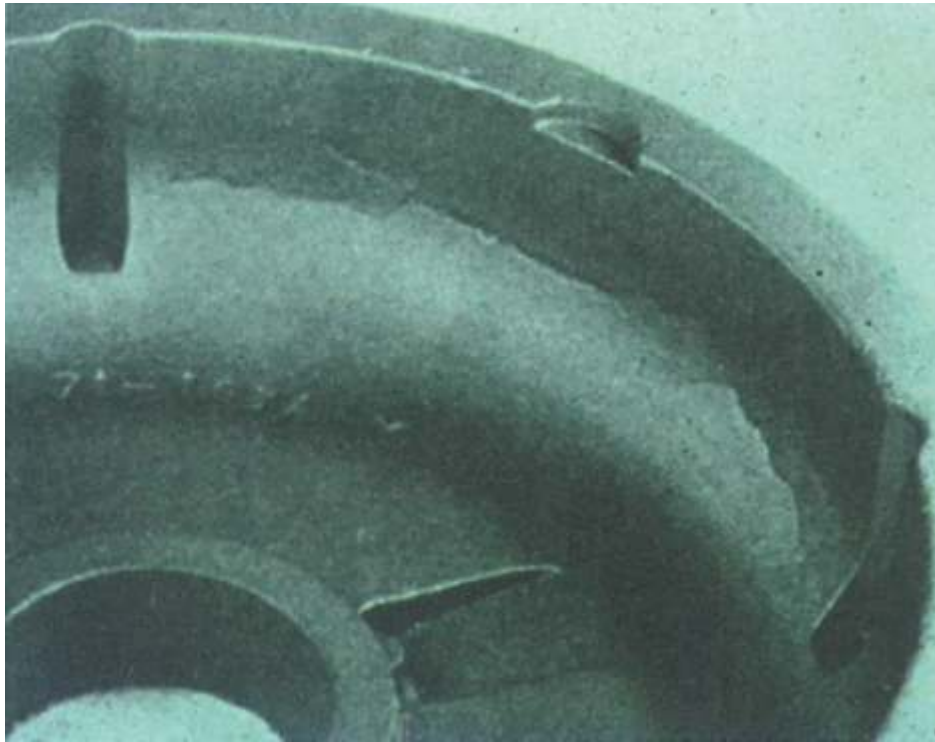
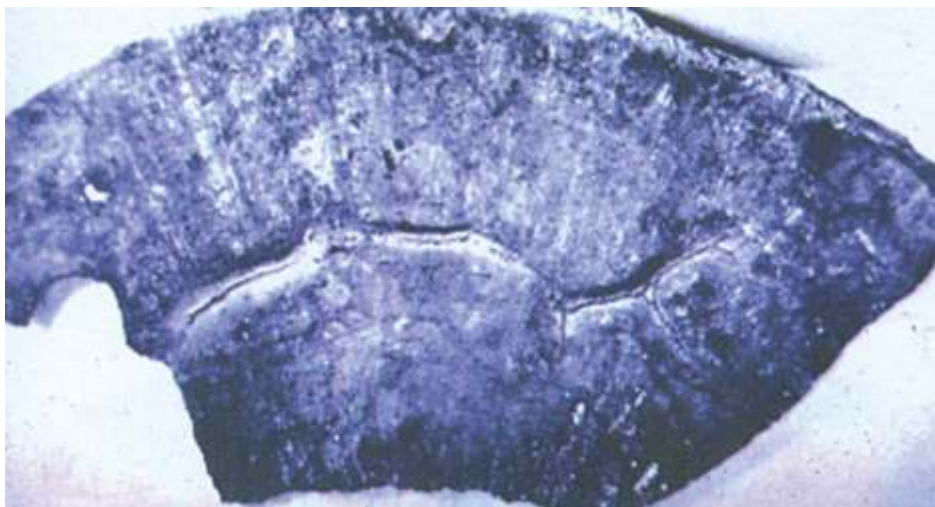
A buckle is a 'heaving' of the sand during pouring and is a precursor to an expansion defect. This often occurs on both horizontal cope and drag surfaces.

Fig. 3-4. Buckle.

Fig. 3-5. Buckle.

Fig. 3-6. Buckle.

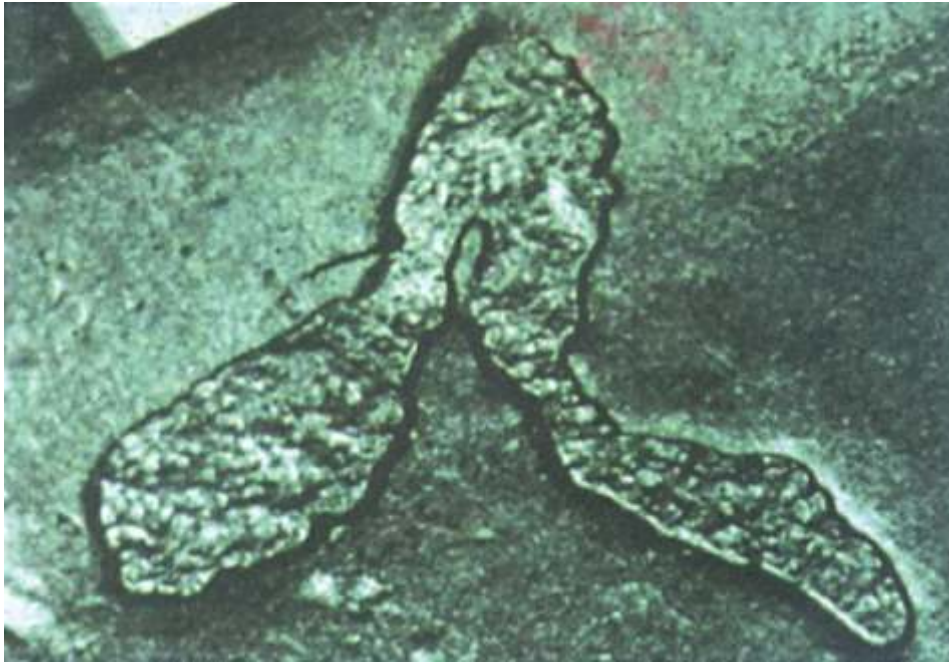
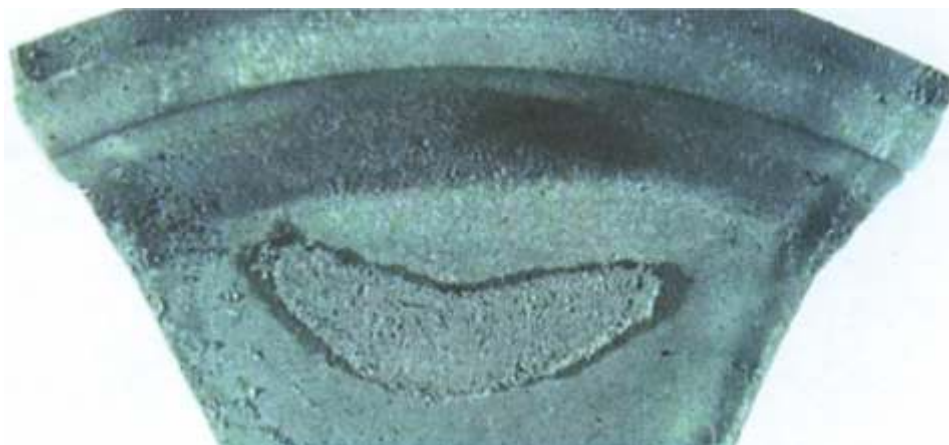
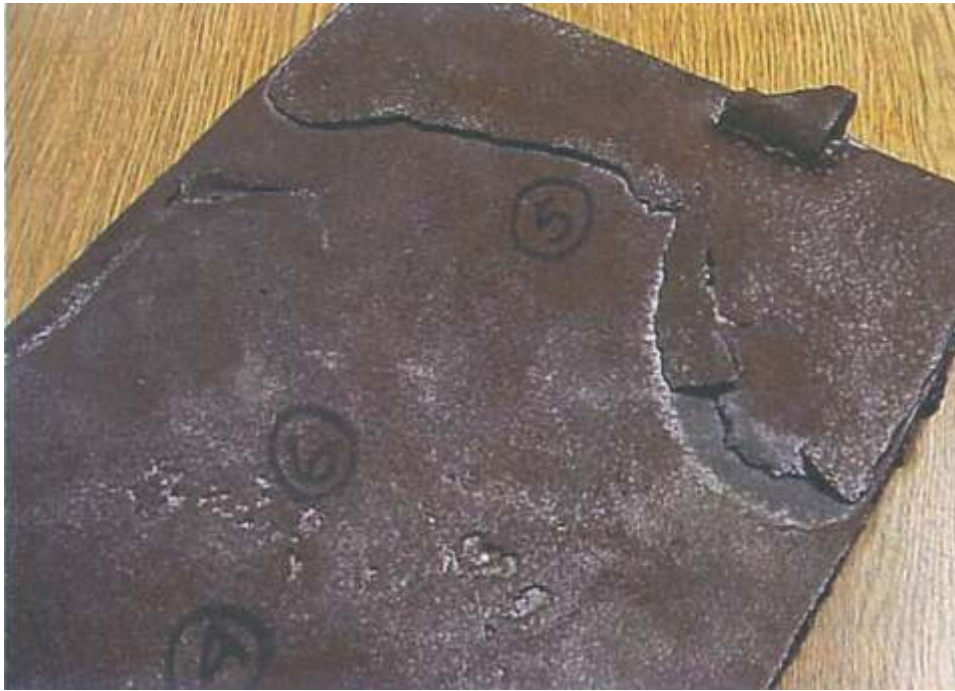
A scab expansion defect occurs as the mold surface undergoes expansion and contraction during pouring and metal solidification. This defect may result from breakdown of the sand or also from erosion of mold and core washes. Scabs are 'positive' metal defects; appear crusty; may be somewhat 'loose' and can often be removed during finishing operations, if not severe.

Fig. 3-7. Scab.

Fig. 3-8. Scab.

Fig. 3-9. Scab.

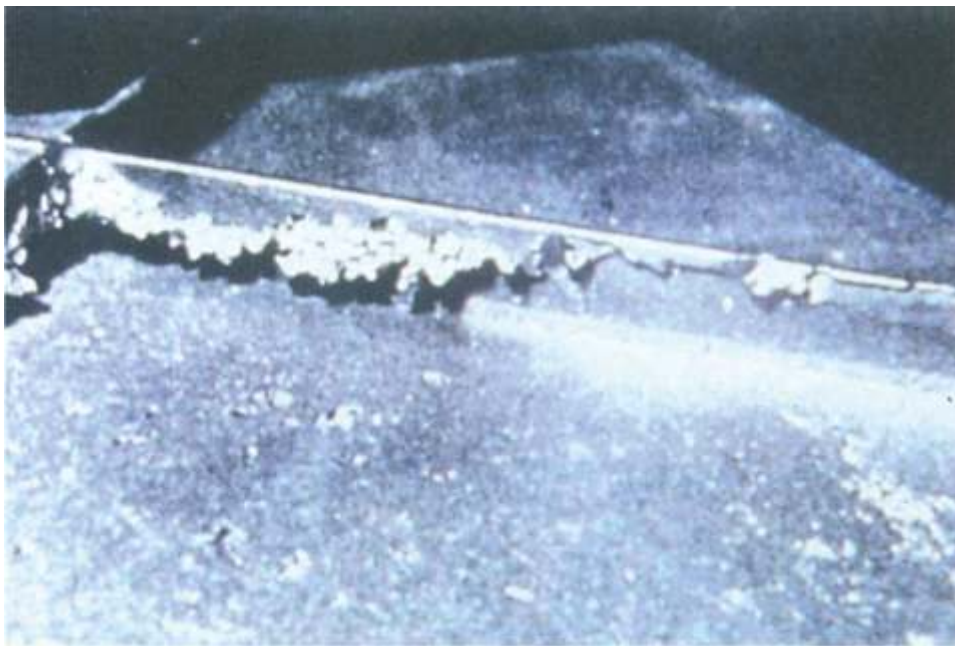
Fig. 3-10. Fillet scab.

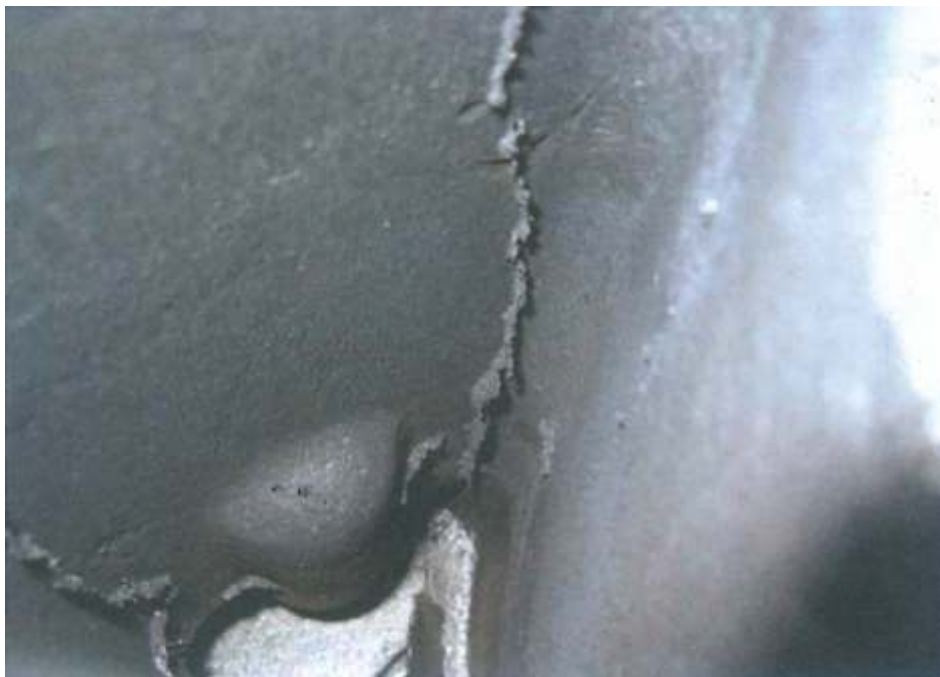
Veining, an irregular linear defect, a ridge or projection on the casting surface, is found in the sandcasting process. Invariably there is a separation in the molding media for various reasons, and the metal fluidity is sufficient to penetrate the separation or crack in the mold and/or core material. This allows the defect to appear when the casting surface is examined.

Fig. 3-12. Veining.

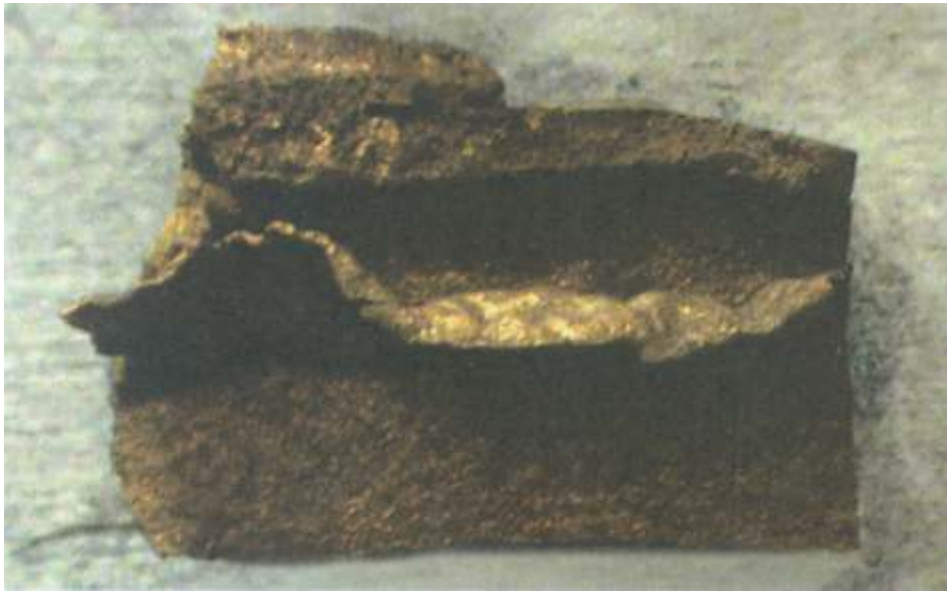
Fig. 3-13. Severe veining in red brass C83600.

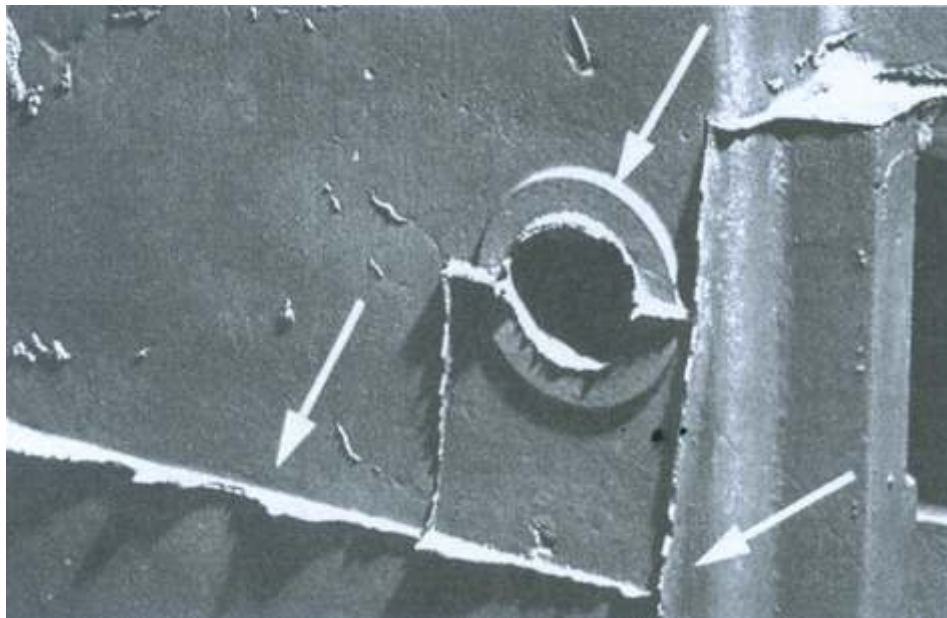
Flash or finning should not be confused with veining. Flash and/or finning occurs as a positive defect, which appears linearly at the mold parting line. This defect is due to inadequate mold closure or mold mismatch. In severe situations, flash or finning becomes gross run-out.

Fig. 3-14. Flash and fins.

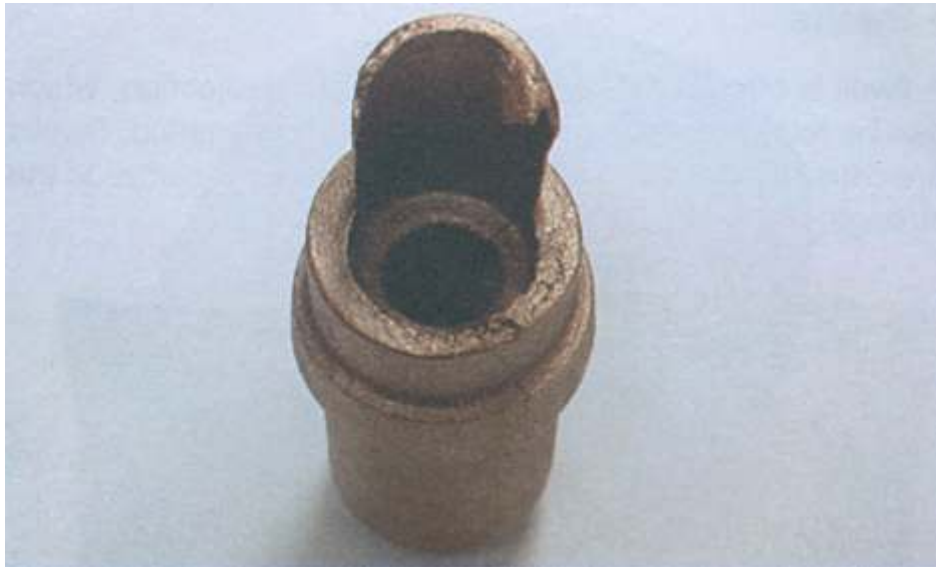
Fig. 4-2. Core crush from insufficient core strength.

A crush is a non-geometric projection on vertical or oblique surfaces of the casting in the direction in which the mold is closed or in which a core is placed.

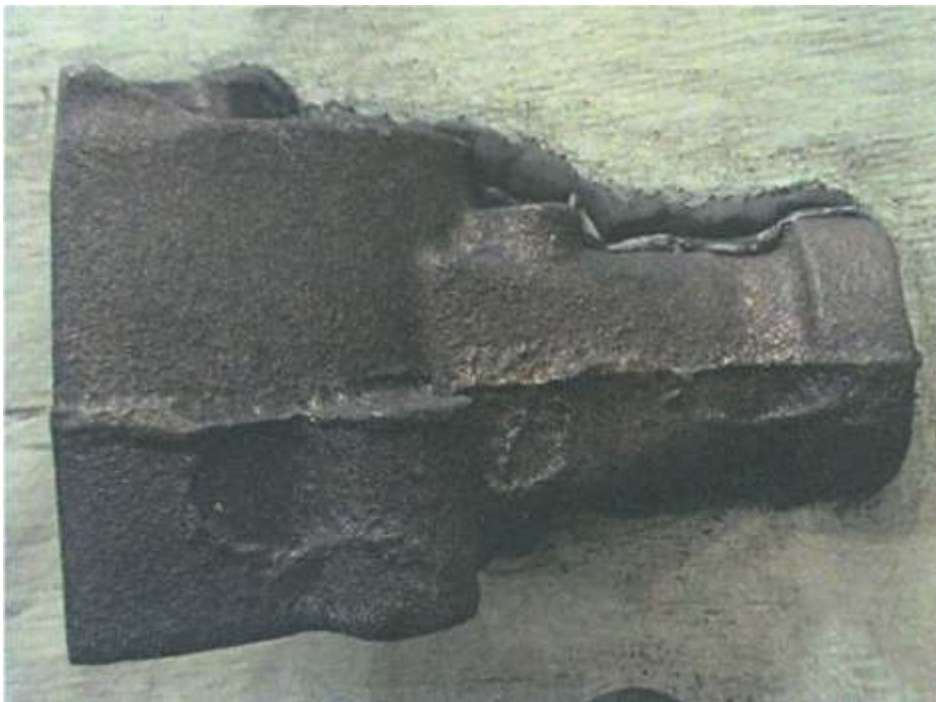
Fig. 4-3. Crush can be caused by misaligned cope/drag, mismatched pattern halves, bad pins, and bushings.

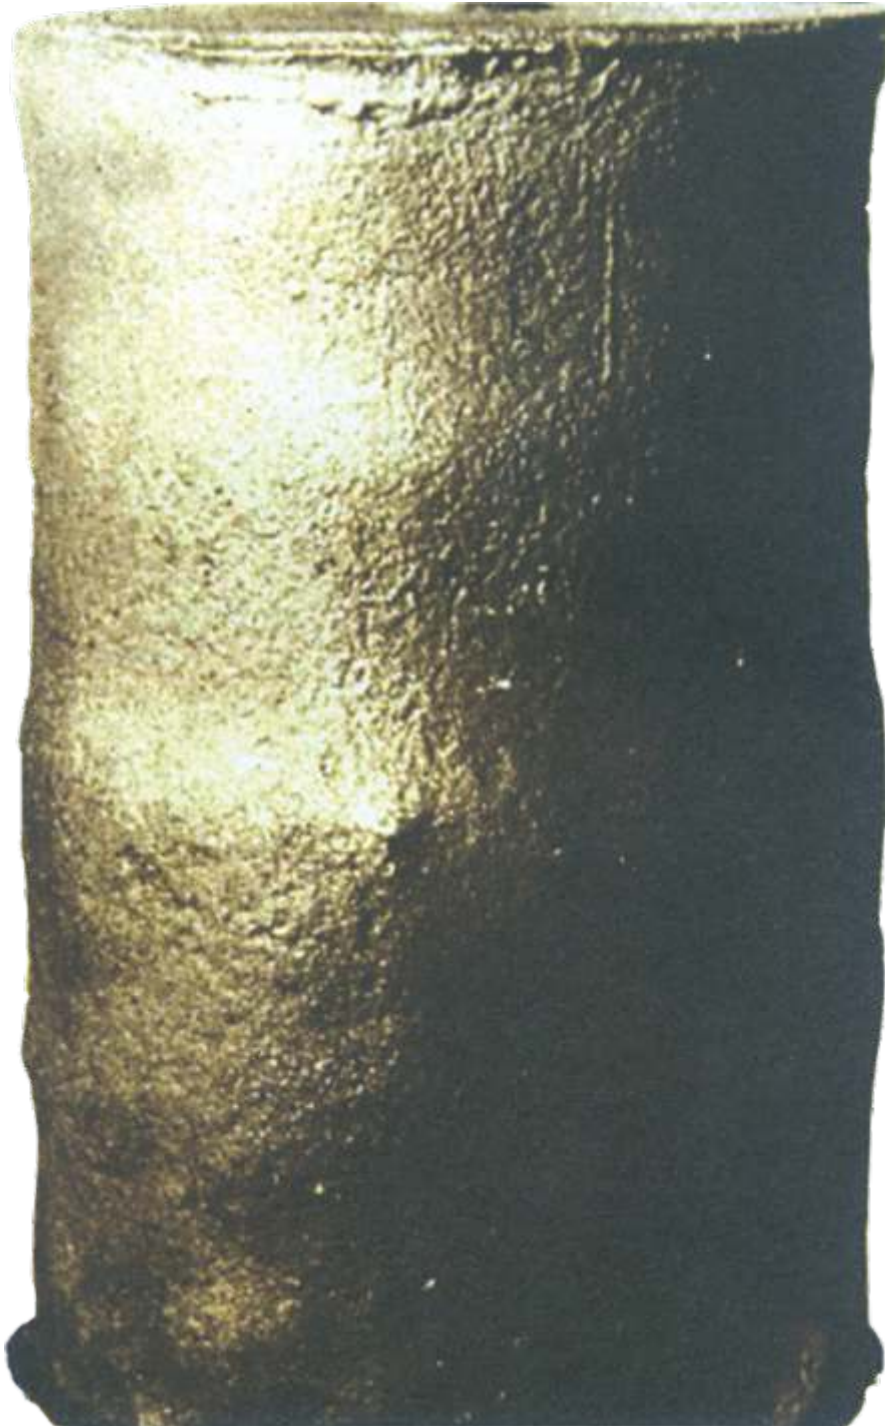
A swell is often a massive 'wavy' irregular projection, which can be found on all surfaces of the problem casting. Swells are caused by excessive liquid metal pressure relative to the strength of the mold.

Fig. 4-4. Swell.

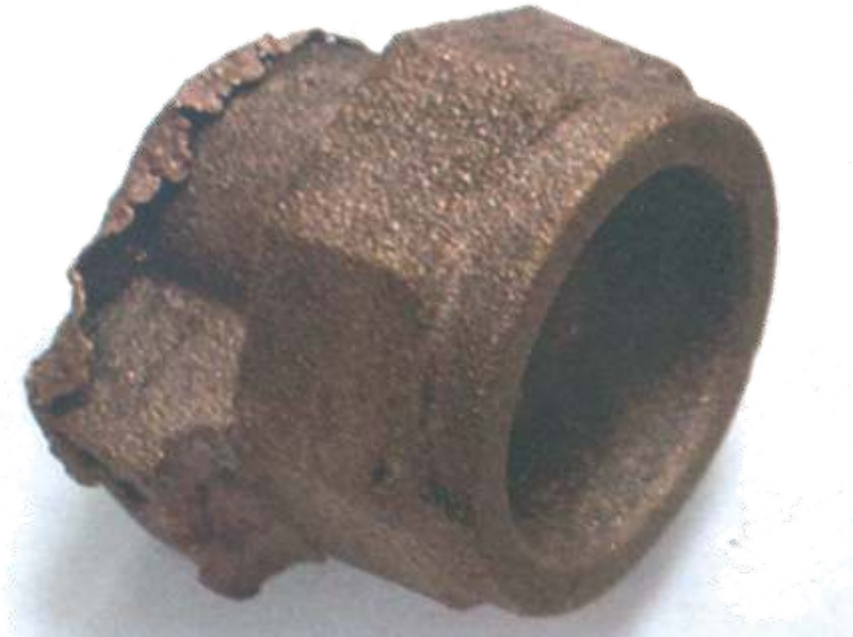
Fig. 4-5. Swell is caused by cracked sand mold in red brass (C83600).

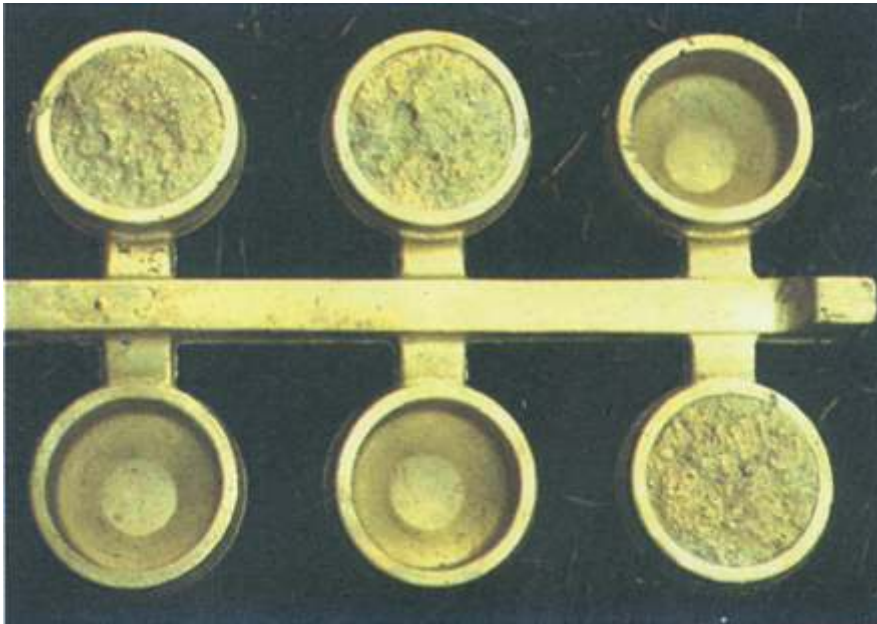
Fig. 4-9. Sticker.

A sticker defect is an irregular massive projection usually found on the cope surface and suggests a detachment of the mold wall. Stickers can be mechanically related-pattern equipment, molding apparatus or inadequate sand molding procedures.

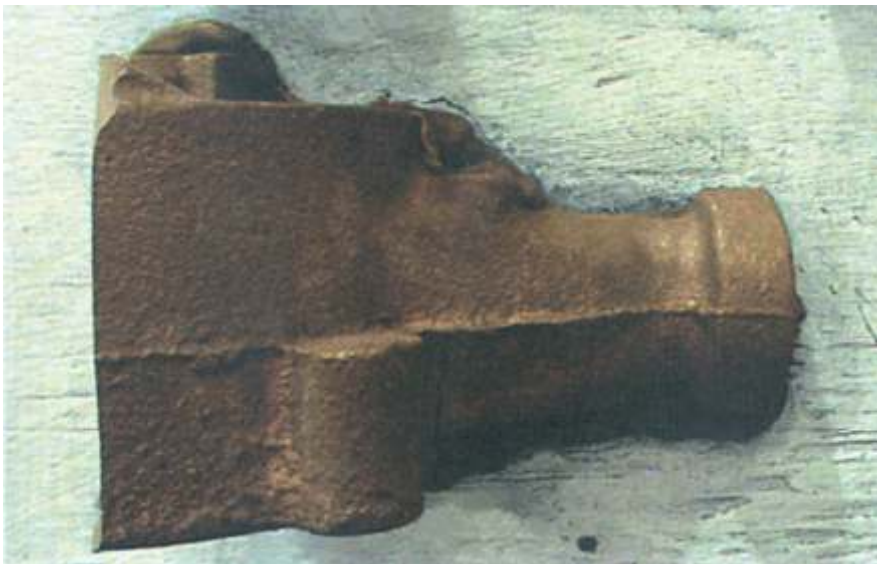
Fig. 4-10. Sticker is caused by poor sand molding and pattern problems.

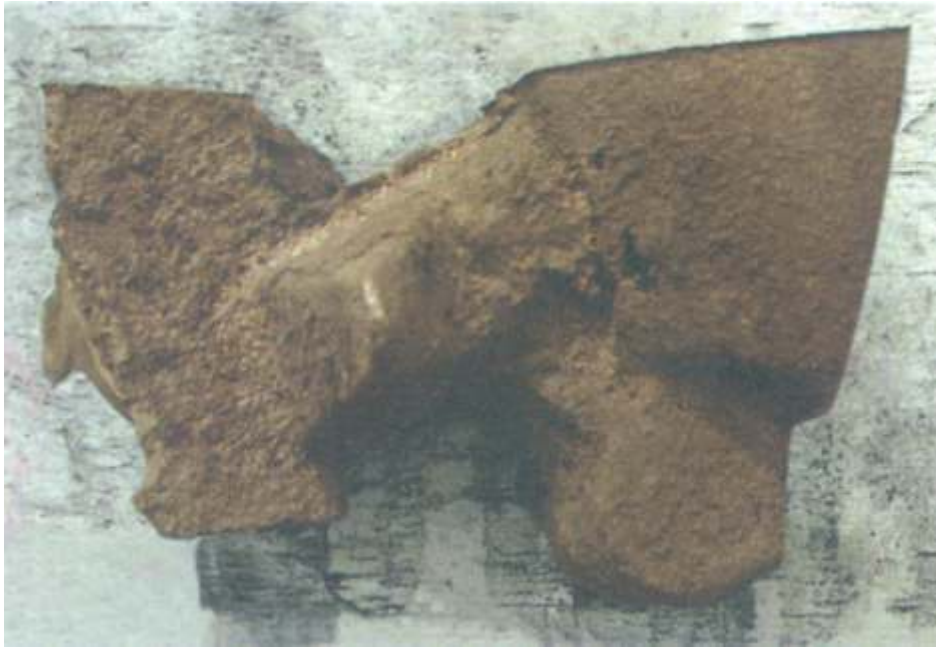
Fig. 4-12. Wash.

Cuts and washes are irregular, rough projections on the surfaces of a casting. They are usually in the vicinity of gates or on the drag surface following a line along the course of metal flow into the mold cavity.

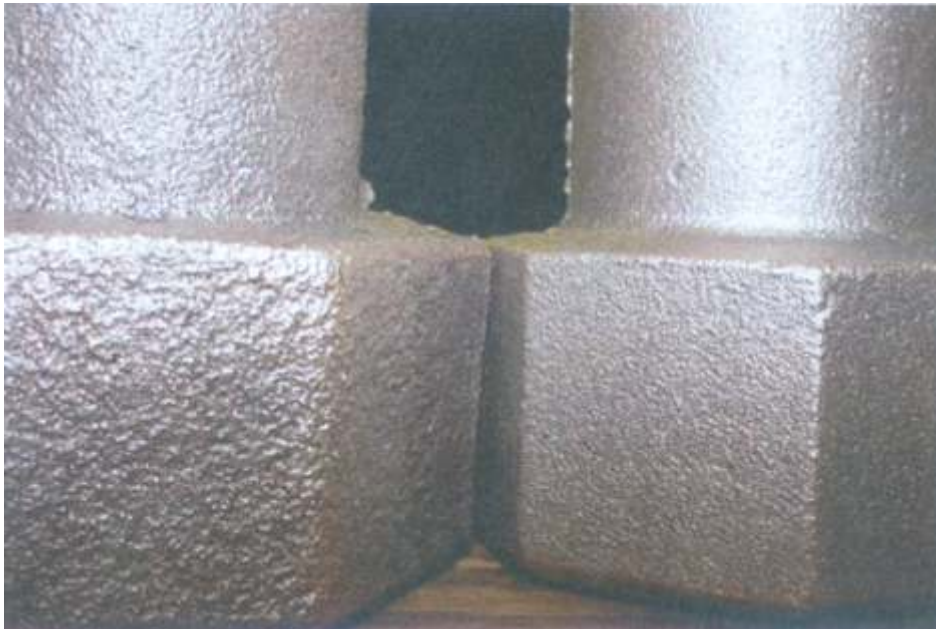
Fig. 4-13. Rough surface on red brass is due to wet sand (moisture too high).

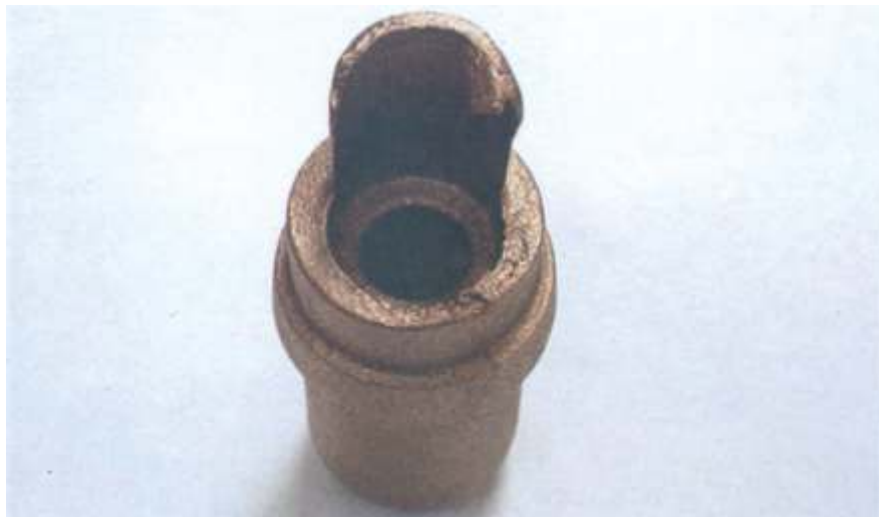
Fig. 4-15. Dimensionally incorrect core in red brass results in crush.

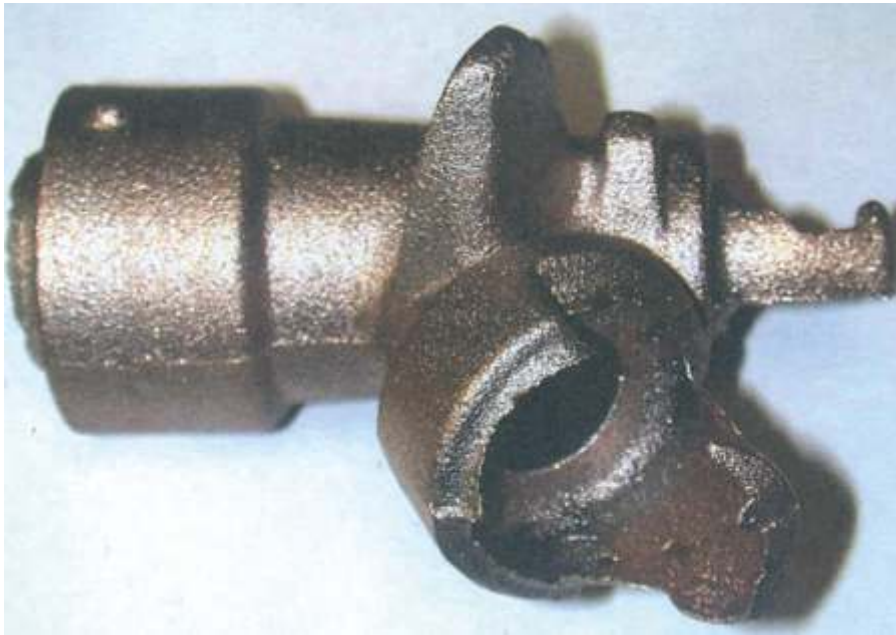
Fig. 4-16. Improper core alignment in red brass.

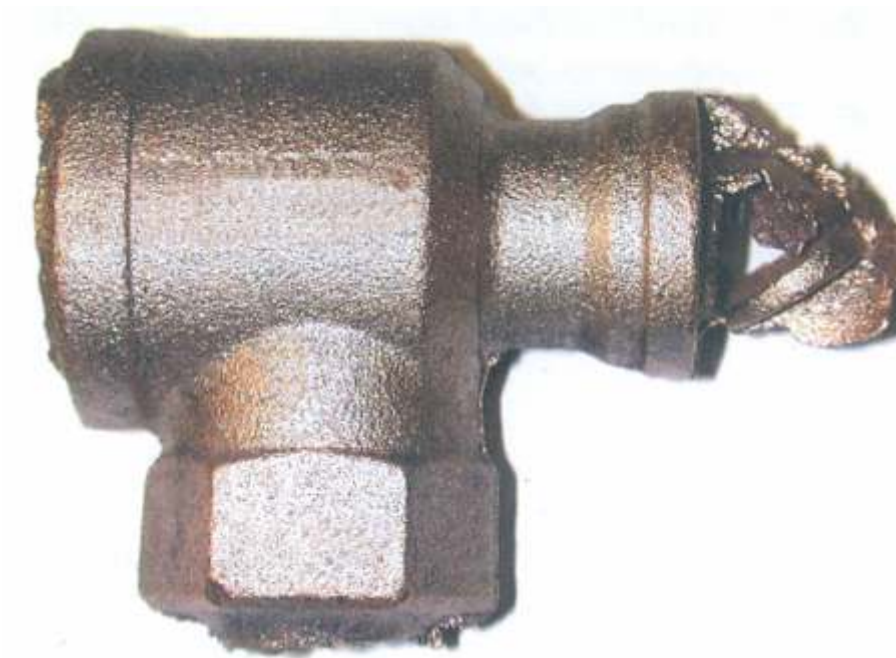
Fig. 4-17. Improper core placement in red brass.

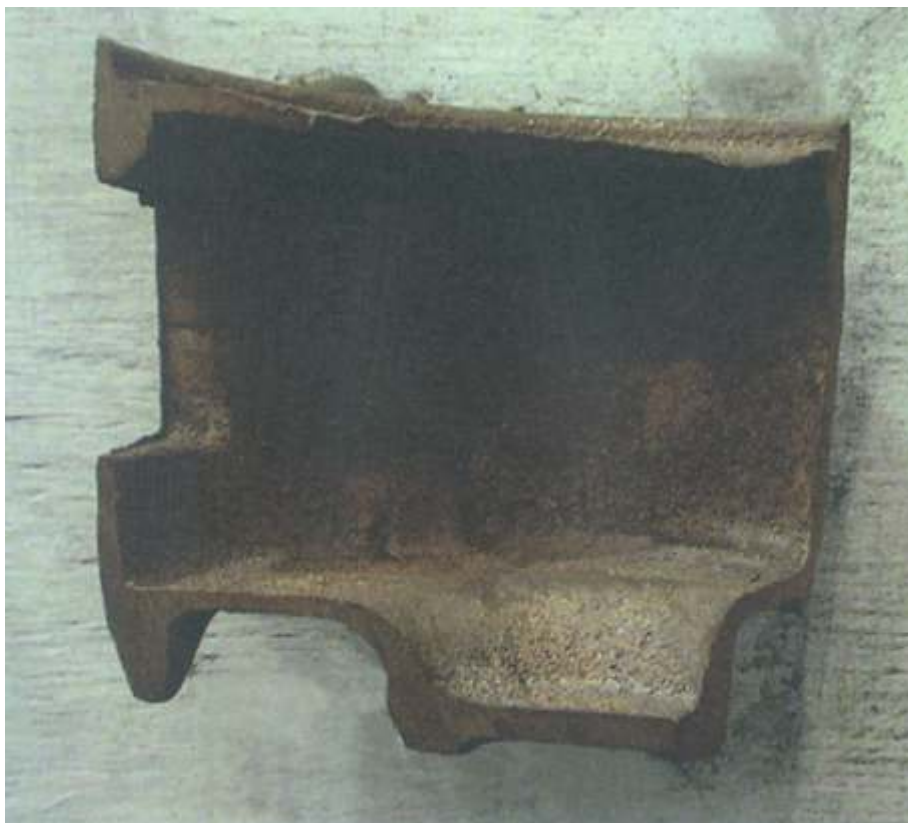
Fig. 4-18. Core lift results from inadequate placement; worn core prints allow 'float' in the mold.

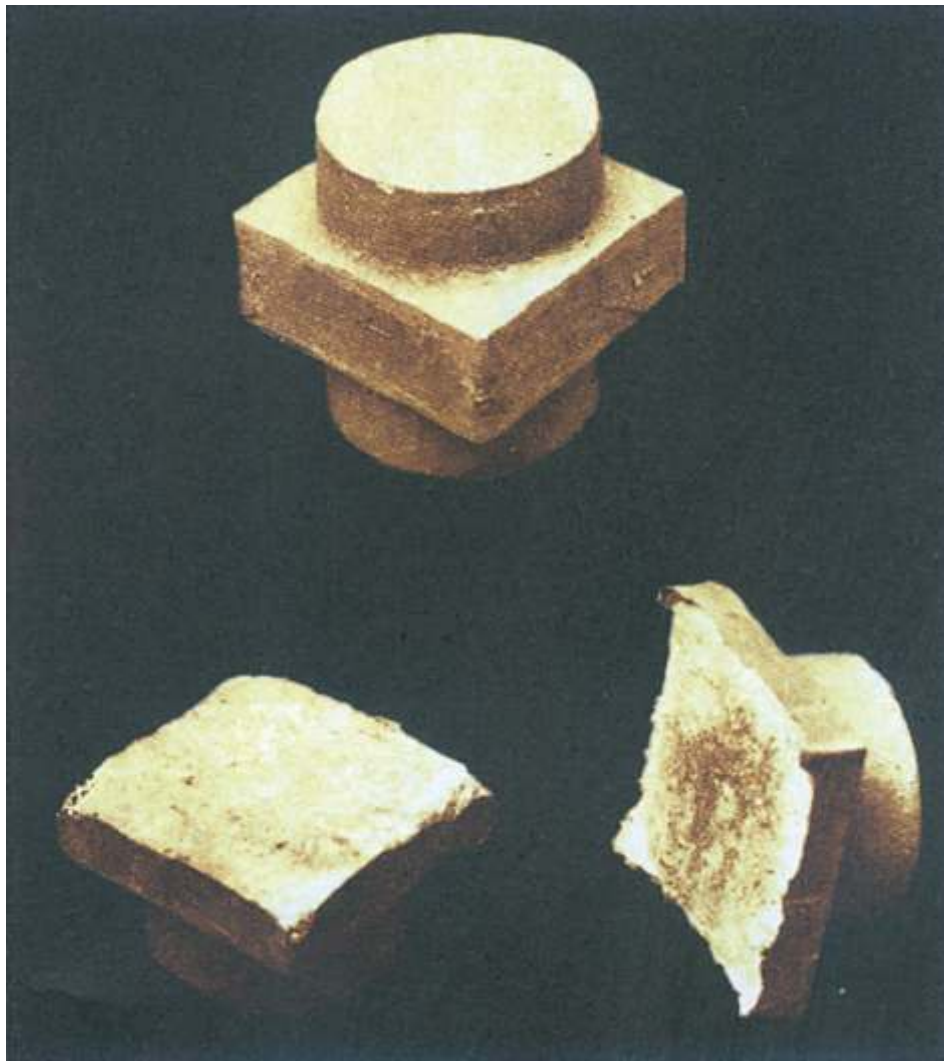
Fig. 5-1. A bronze screw nut cast in green sand shows effect of interrupted pouring.

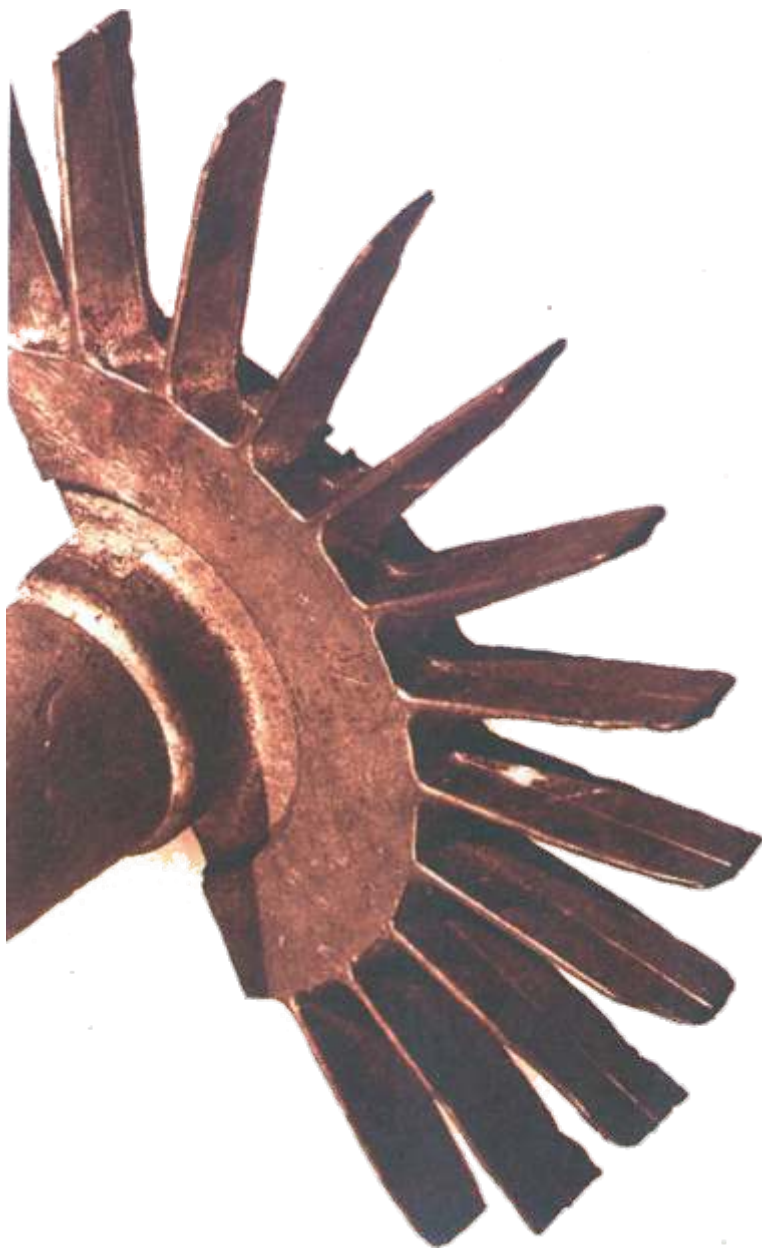
Fig. 5-2. A cupro-aluminum permanent mold casting exhibits a misrun due to lack of venting.

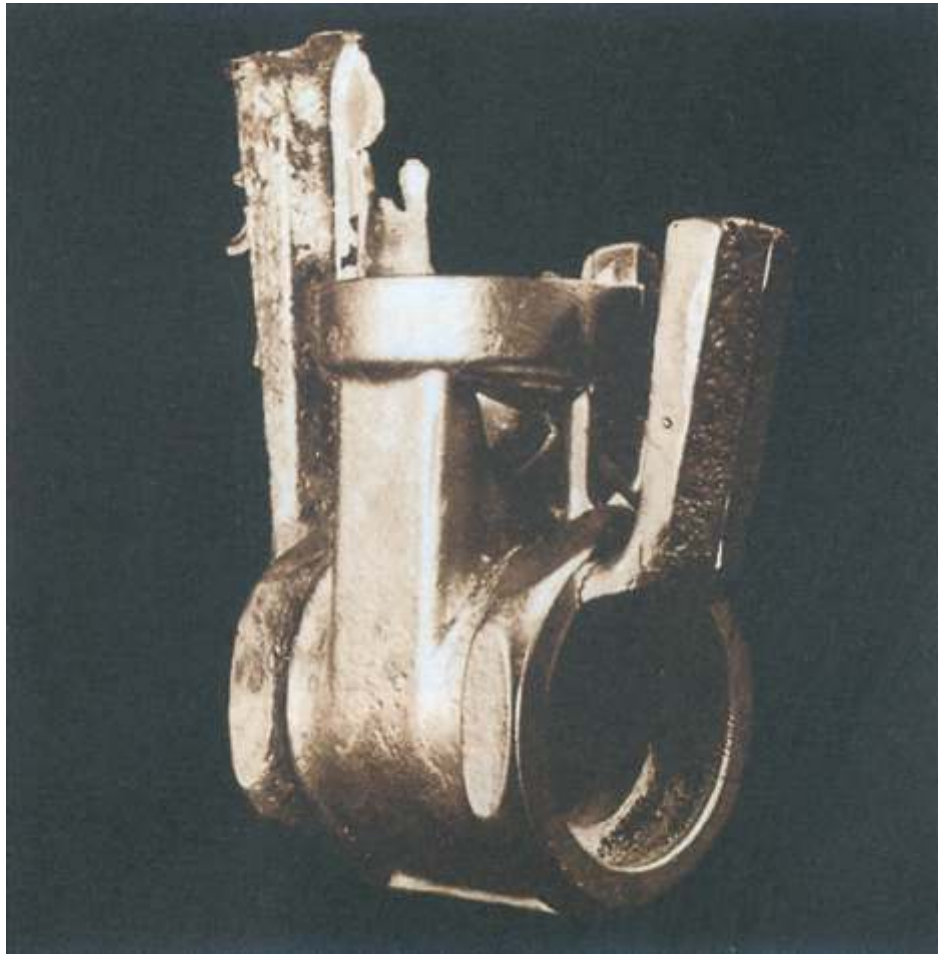
Fig. 5-3. A brass valve body cast in permanent mold shows a misrun caused by entrapped air.

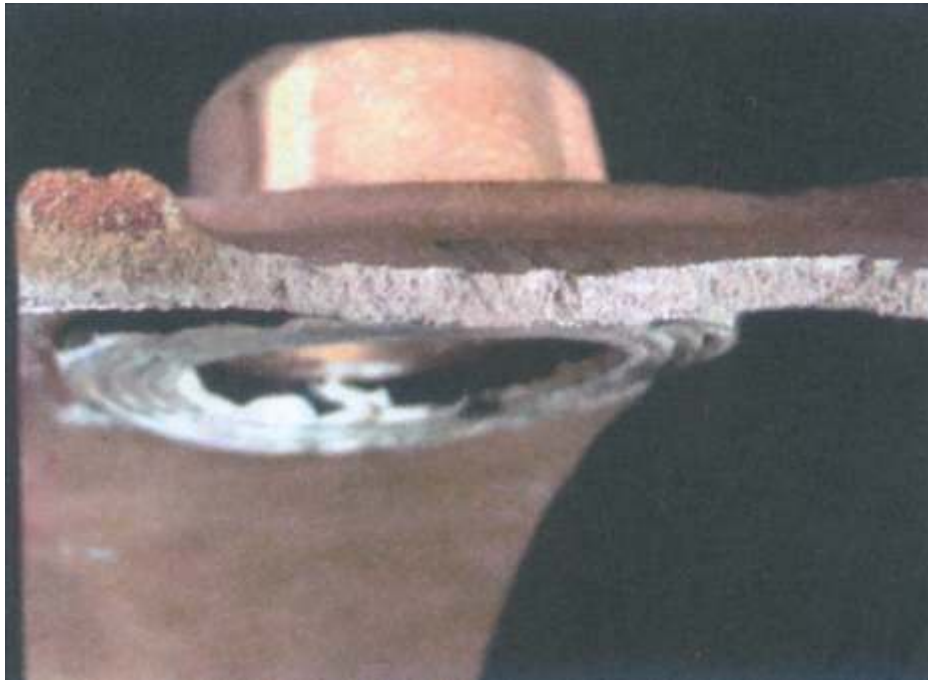
Fig. 5-5. Unsatisfactory ingate solidification in leaded red brass.
