COPPER BASE ALLOYS

CASTING DEFECTS

COPPER BASE ALLOYS CASTING DEFECTS

Editor: Assistant Prof. Dr. Hikmet ERBIYIK

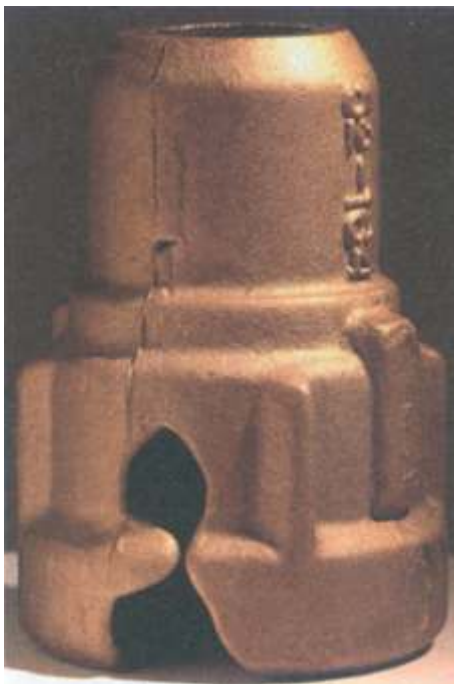
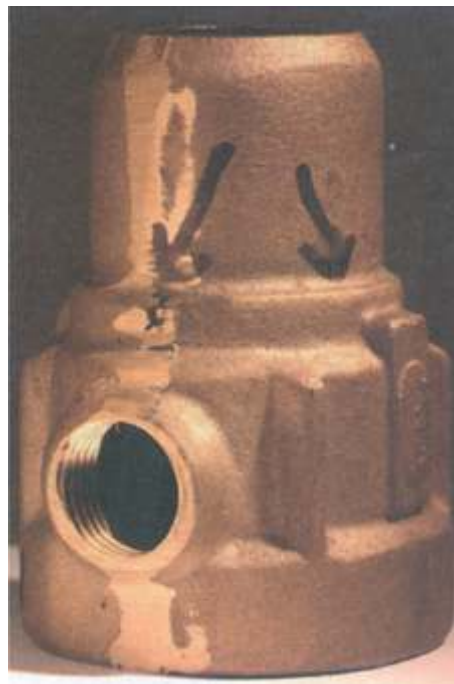
Fig. 5-6. Cold shut and incomplete filling is visible in this red brass casting: (a) left view and (b) right view. Possible causes (any and all) include core gas evolution, inadequate venting, and low pouring temperature.

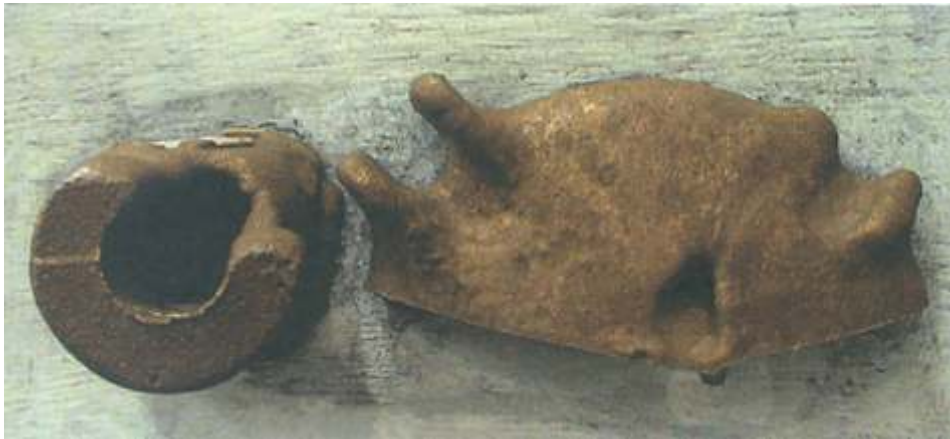
Fig. 5-8. A misrun in red brass is caused by low temperature, inadequate gating and low phosphorus deoxidation.

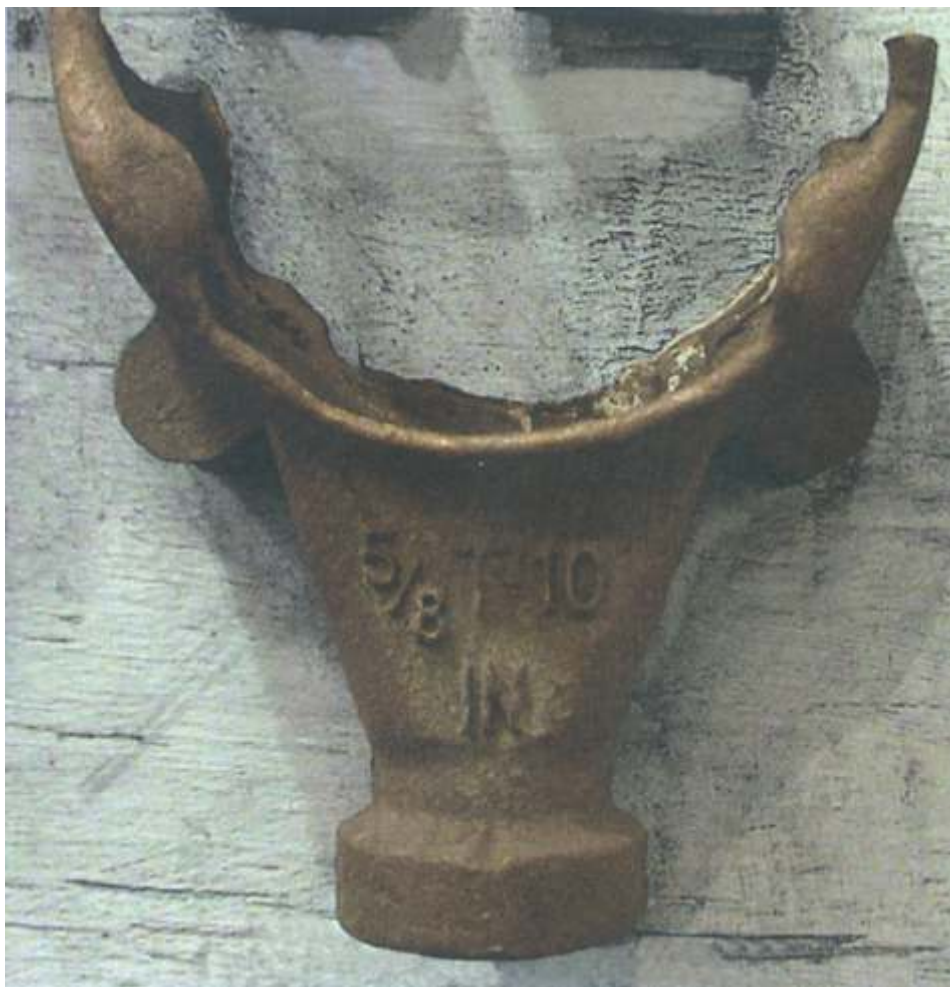
Fig. 5-9. A red brass casting shows a short pour and inadequate volume.

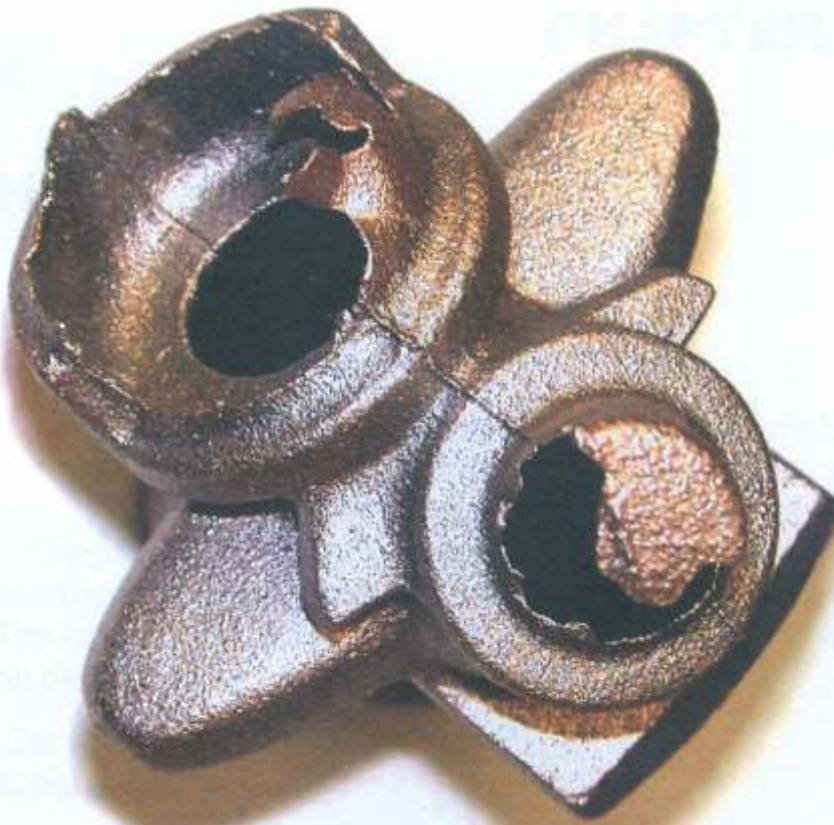
Fig. 5-10. A dimensionally incorrect red brass casting due to core shift.

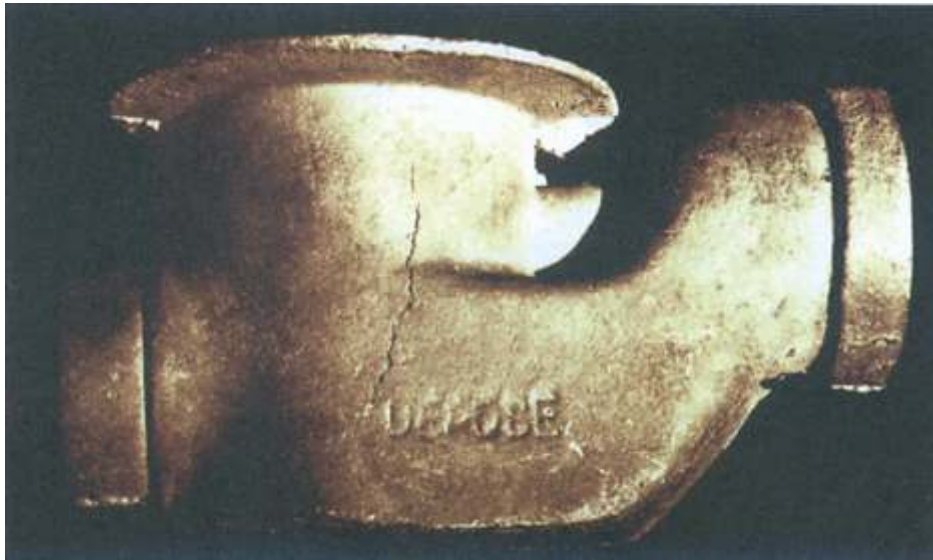
Fig. 6-3. The hot tear in the brass valve body in green sand is due to restrained contraction and excessive pouring temperature.

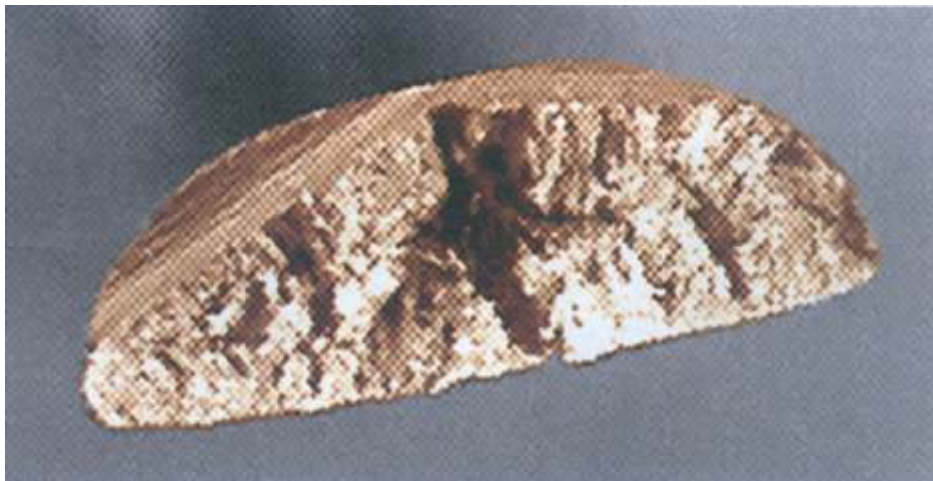
Fig. 6-4. A fracture in red brass cast in green sand exhibits excessive dendrite growth due to excessive melt and/or pouring temperature; venting helps.

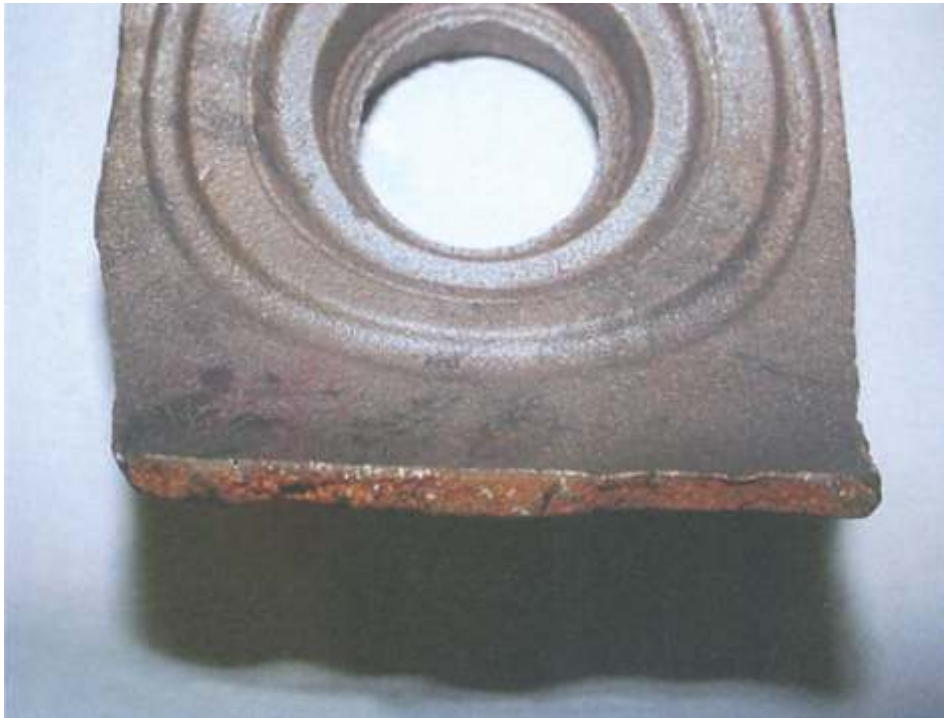
Fig. 6-5. Hot tear in red brass caused by shakeout, which is too soon and/or too hot.

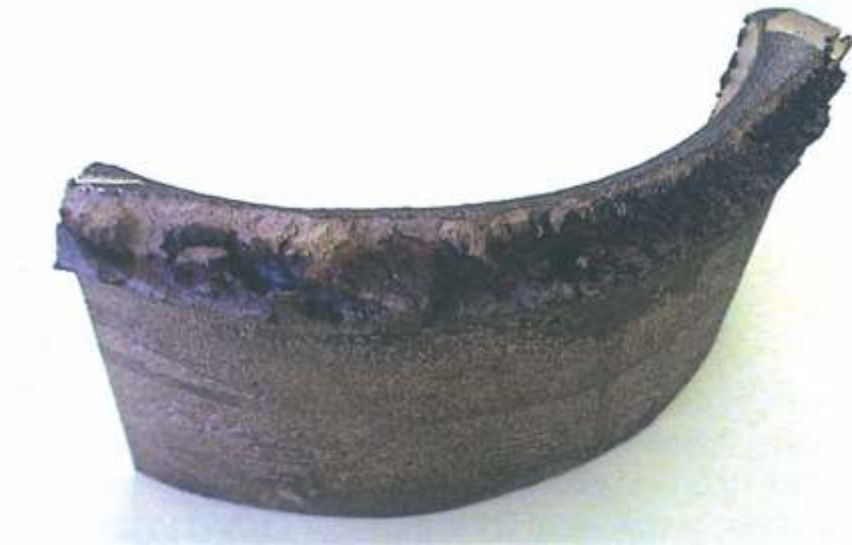
Fig. 6-7. The hot tear in red brass resulted from the binder content being too high and from mold restraint.

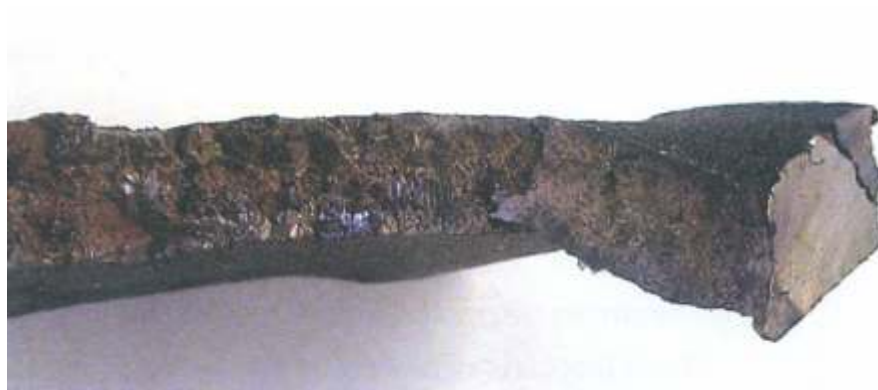
Fig. 6-8. Hot tear in a leaded semi-red brass.

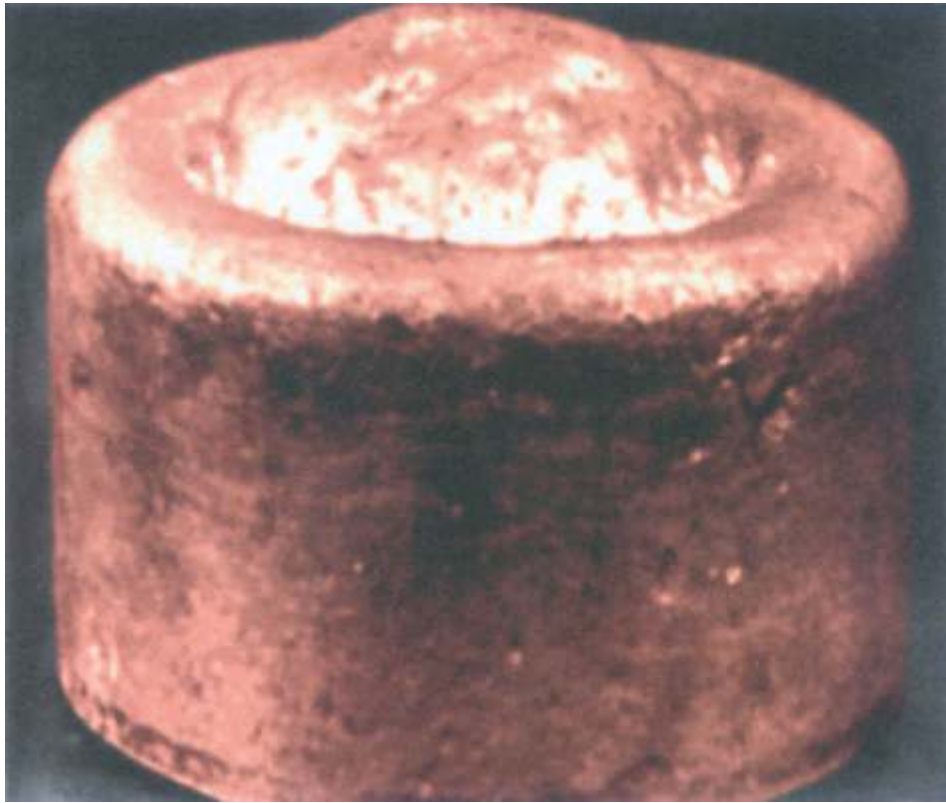
Fig. 7-1. A rise is associated with gas porosity in the casting.

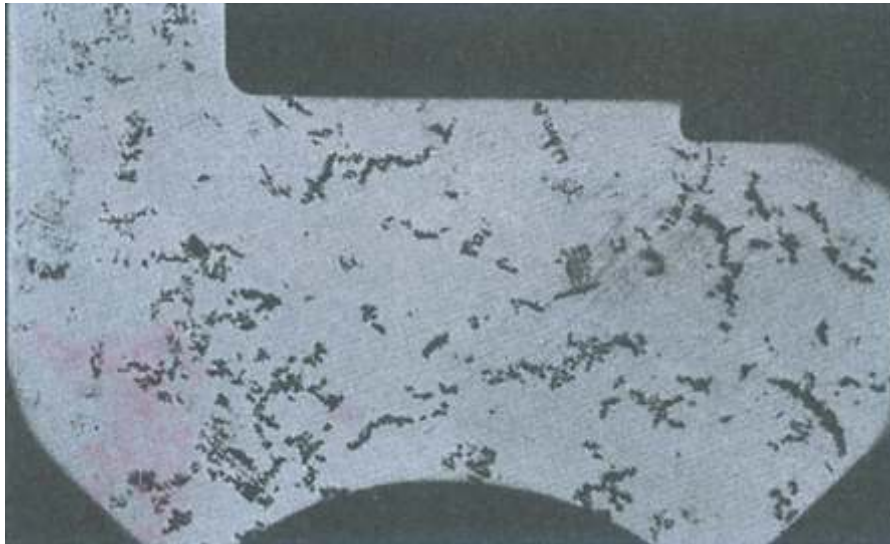
Fig. 7-3. A bronze casting displays macro-porosity.

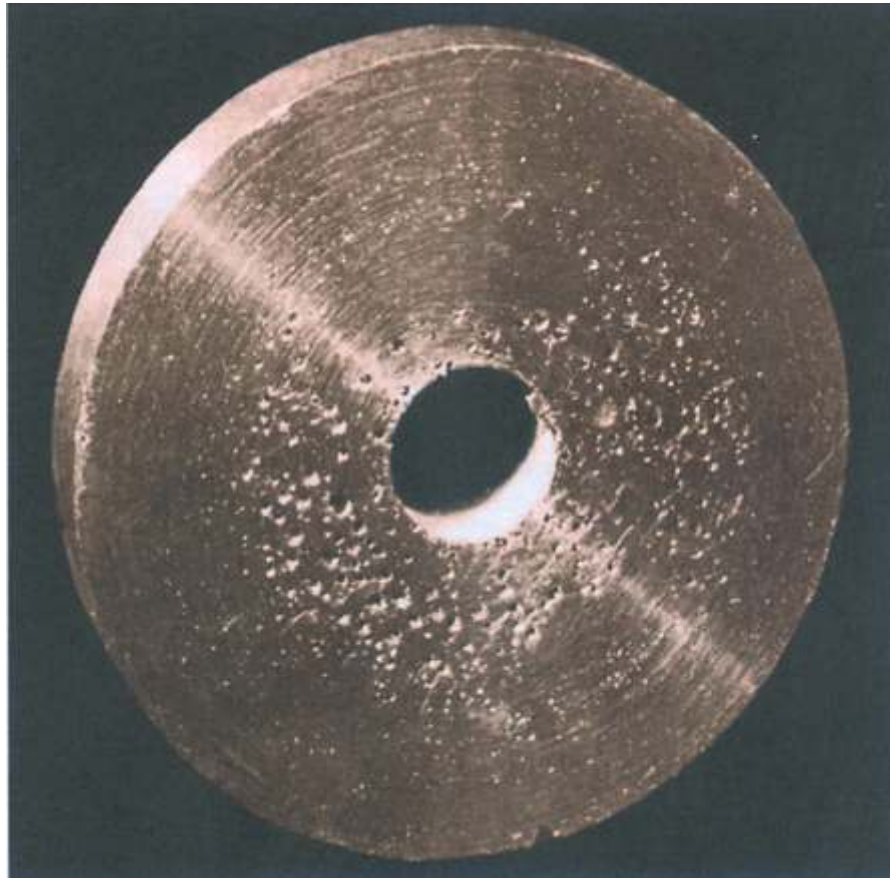
Fig. 7-4. Tin bronze alloy cast in dry sand has blowholes due to gassy melt.

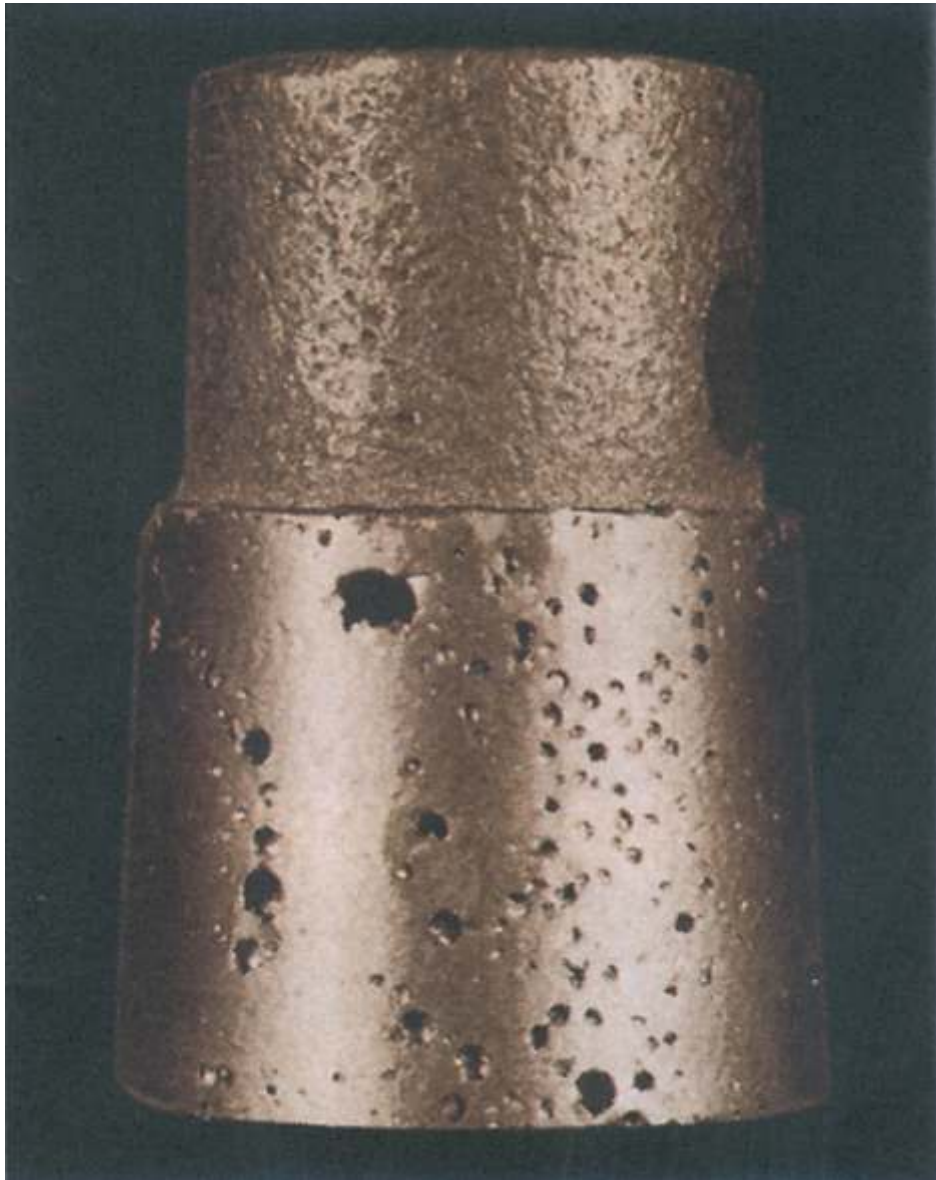
Fig. 7-5. Bronze stopper cast in green sand has blowholes due to gassy melt and/or mold/metal reaction with excessive moisture in the sand.

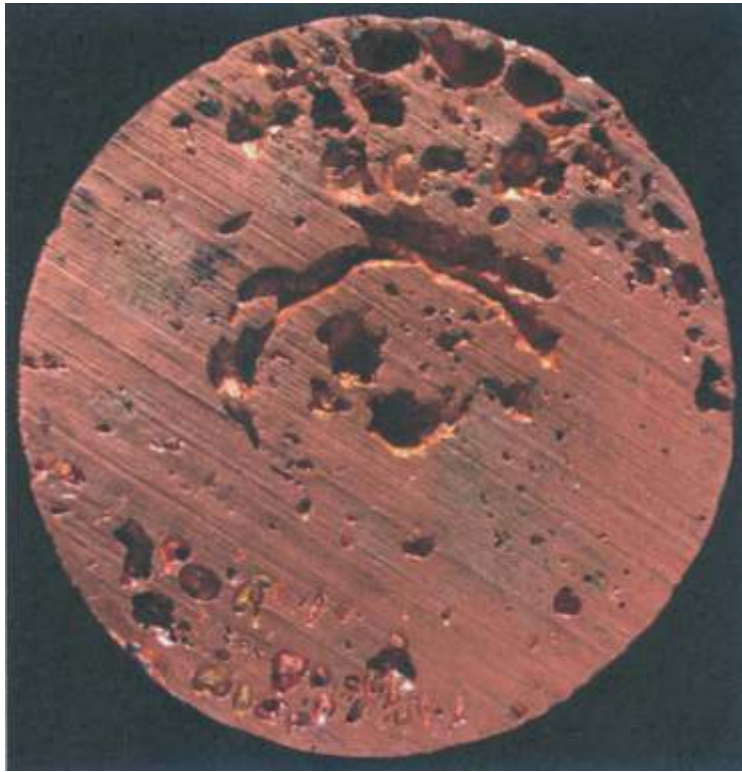
Fig. 7-8. Two views of a high copper casting, exhibiting massive porosity due to poor or no deoxidation and/or degassing.

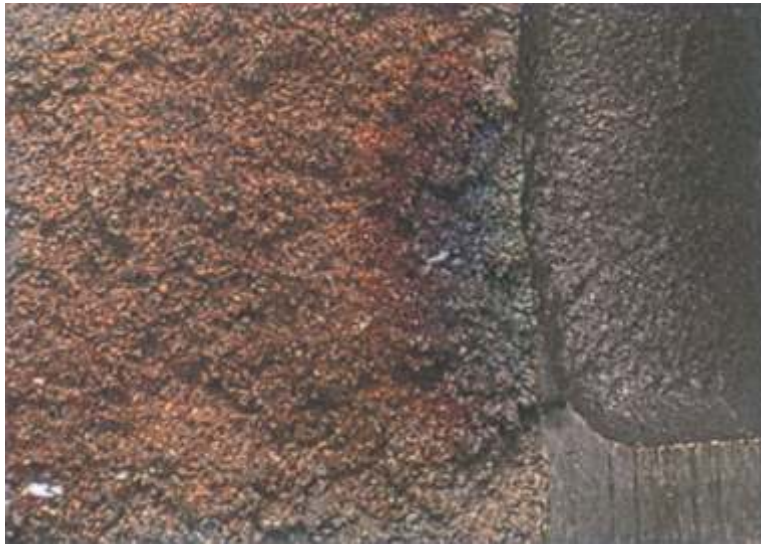
Fig. 7-9. A discoloration and porosity in red brass is due to gas evolution and high pouring temperature.

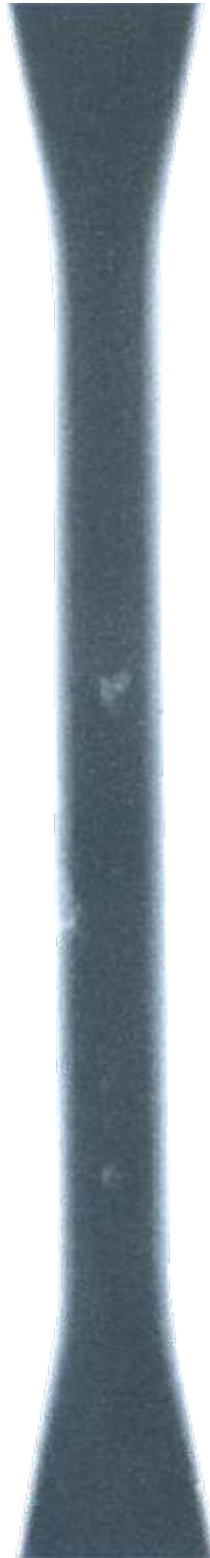
Fig. 7-10. X-ray of cast test bar exhibits gross porosity in brass.

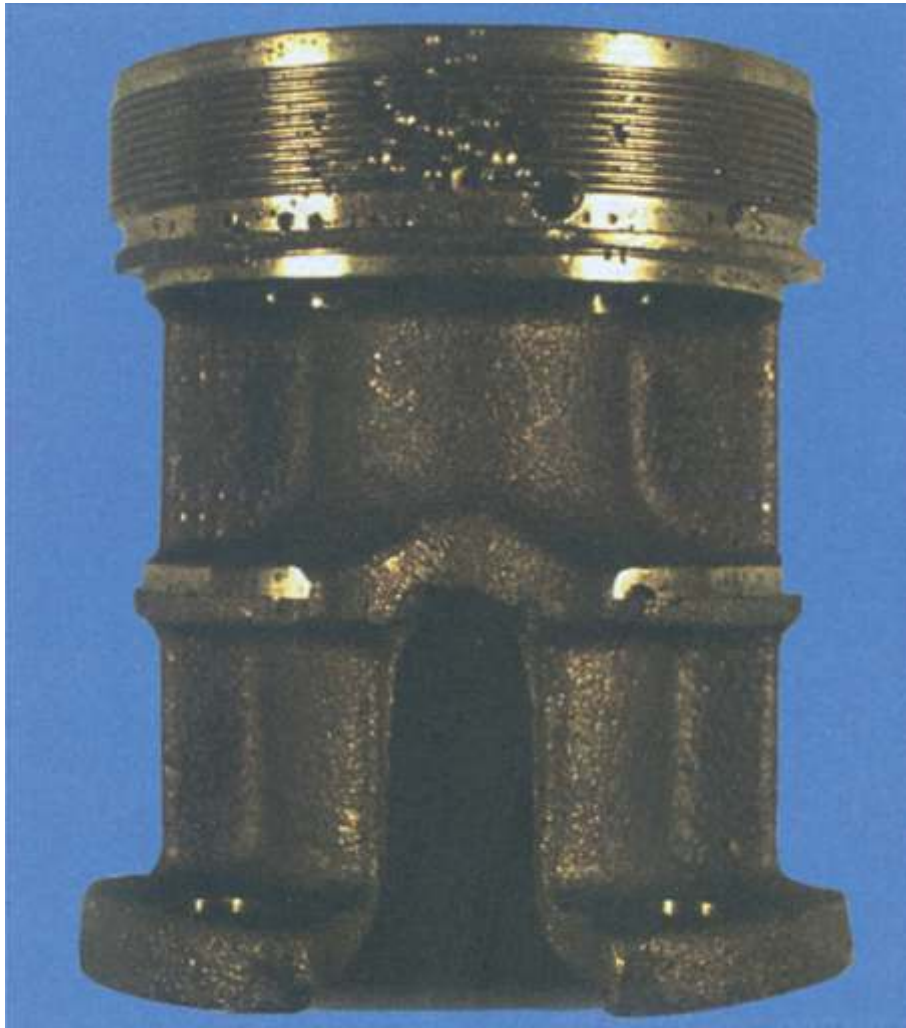
Fig. 7-11. Severe gas porosity is seen in red brass.

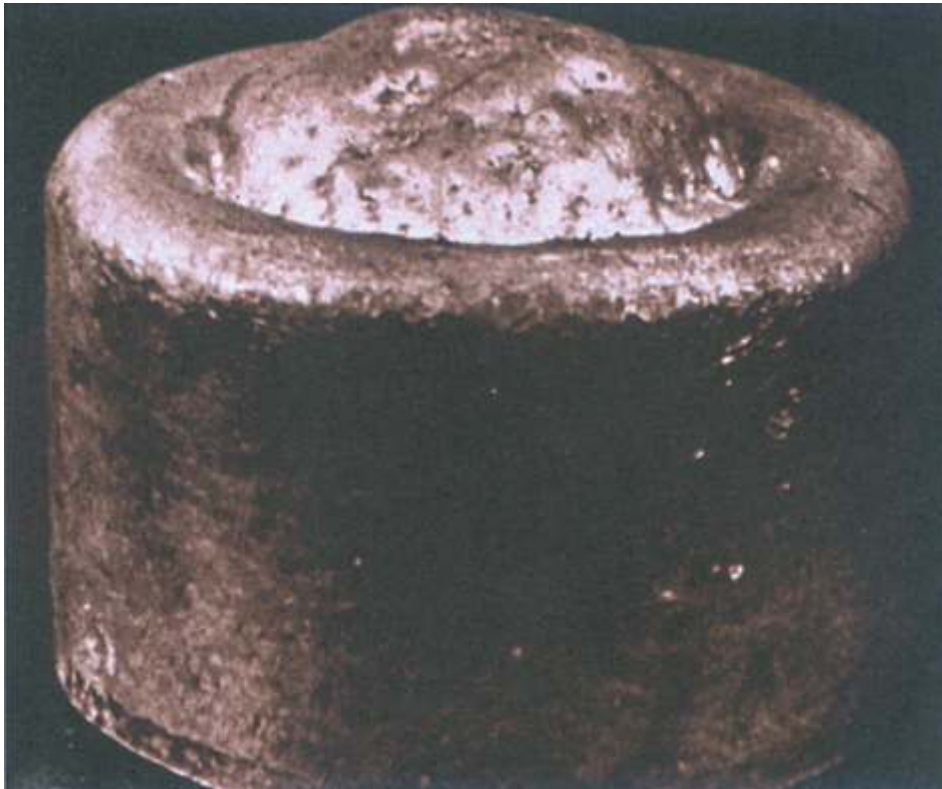
Fig. 7-12. A copper base casting shows a 'mushroom' gas evolution.

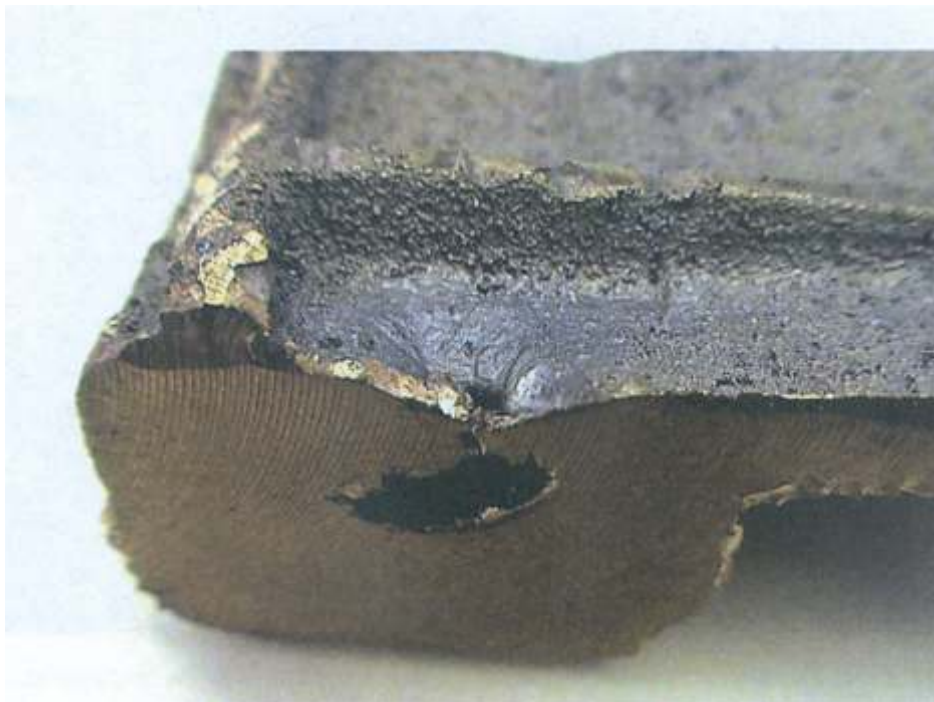
Fig. 7-13. A core gas blow in leaded red brass is the result of poor venting and pouring temperature being too high. Also, inadequate gating causes localized heating at a thick section and a concentrated gas blow within the casting.

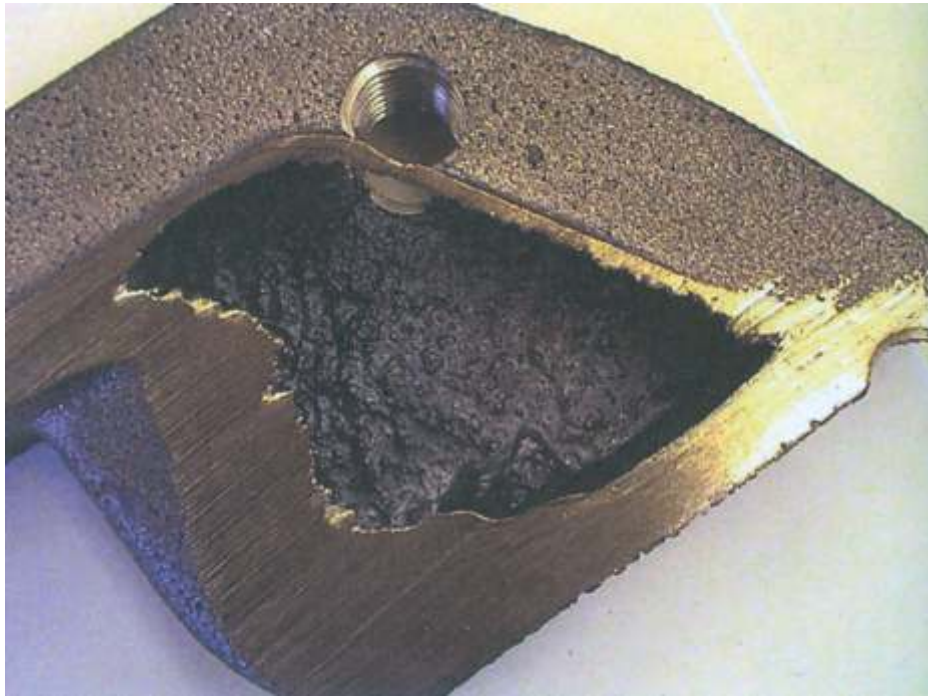
Fig. 7-14. A gross blow and dispersed porosity in red brass is the result of a wet core adhesive and improper venting.

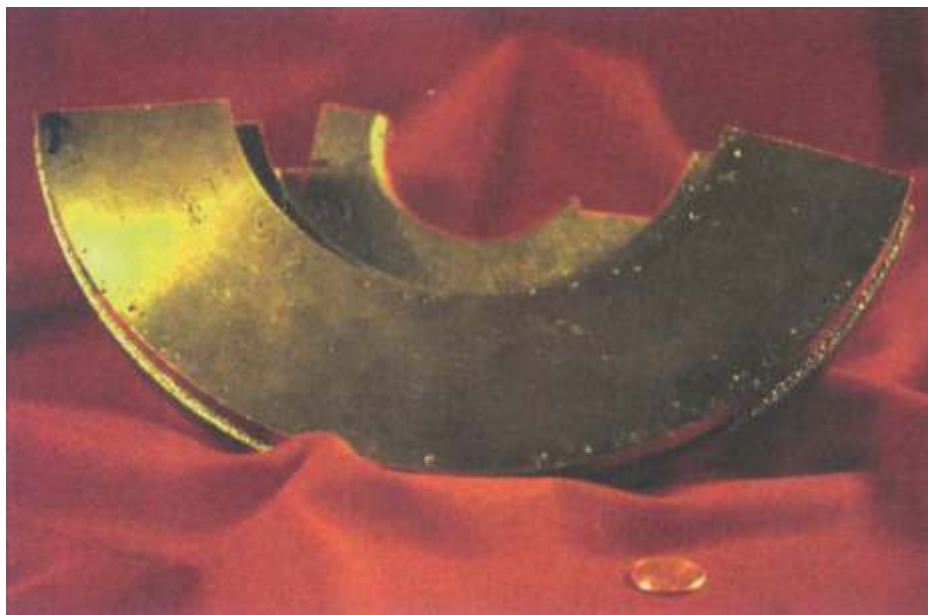
Fig. 7-15. Pinholes in aluminum bronze result from inadequate degassing.

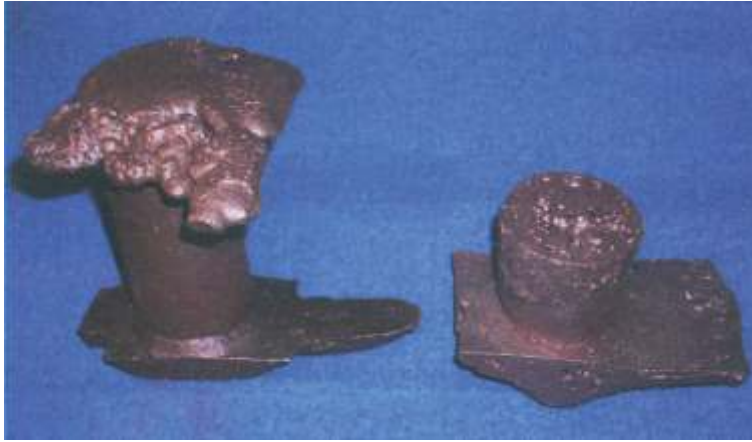
Fig. 7-16. The 'mushrooming' copper casting is due to high gas content in the melt.

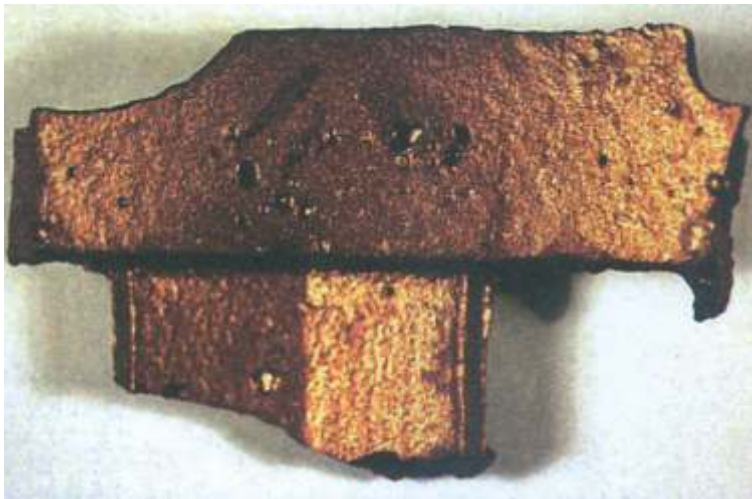
Fig. 7-17. Heavy section brass casting exhibits gas blow during final solidification. Potential solutions are de-gas; provide better feeding; use of chills and lower pouring temperature.

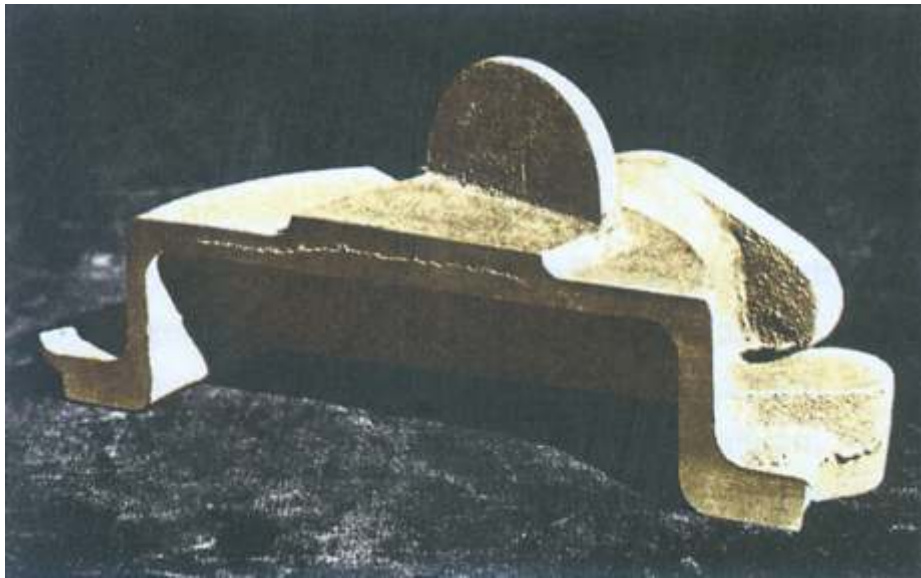
Fig. 8-1. Brass sand casting shows centerline shrinkage crack. Lowering iron and tin content, increasing riser size and reducing pouring temperature would eliminate the shrink.

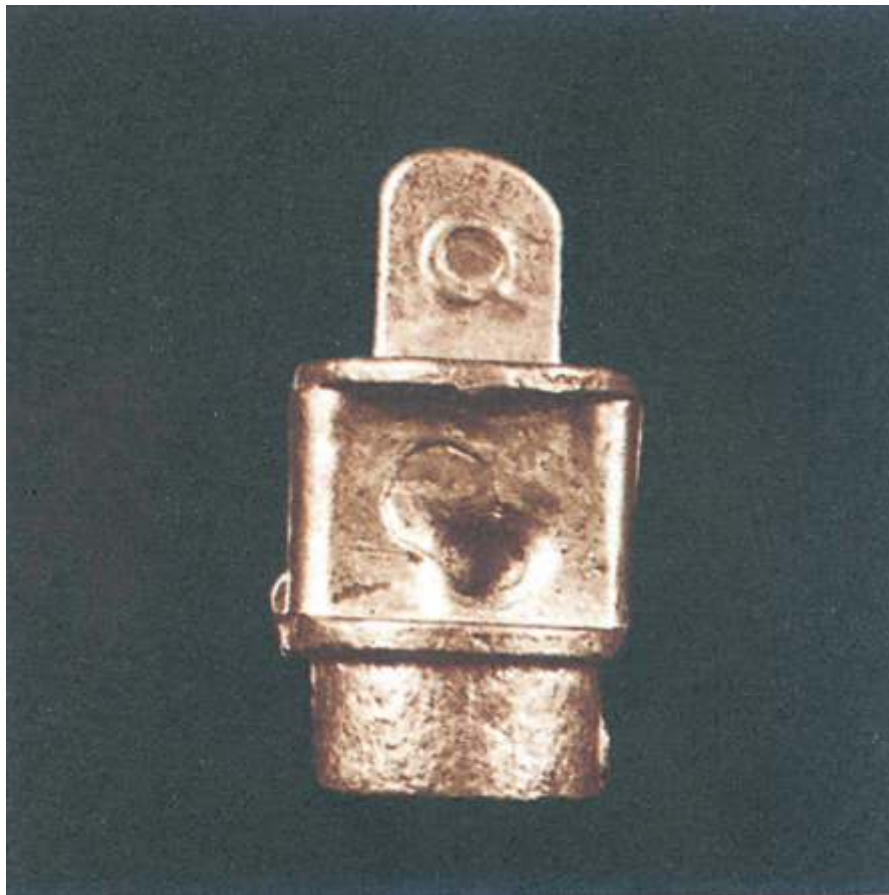
(a) Existing Gating

(b) Better Solution

Fig. 8-2. Permanent mold cupro-aluminum casting exhibits shrinkage cavity due to inadequate feeding through bottom gating into the heavier section.

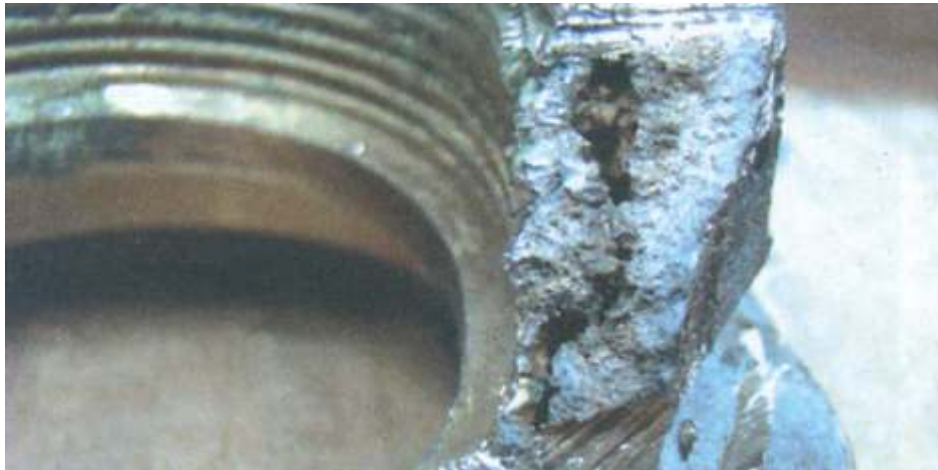
Fig. 8-3. Centerline shrinkage in red brass is caused by insufficient feeding.

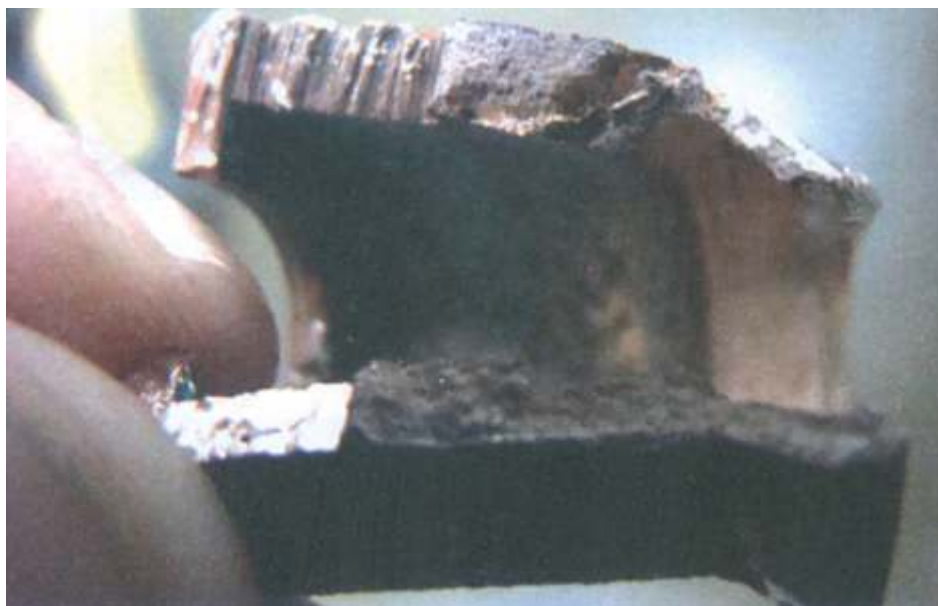
Fig. 8-4. Severe macro shrinkage in leaded red brass is caused by too low of a pouring temperature and/or insufficient feeding.

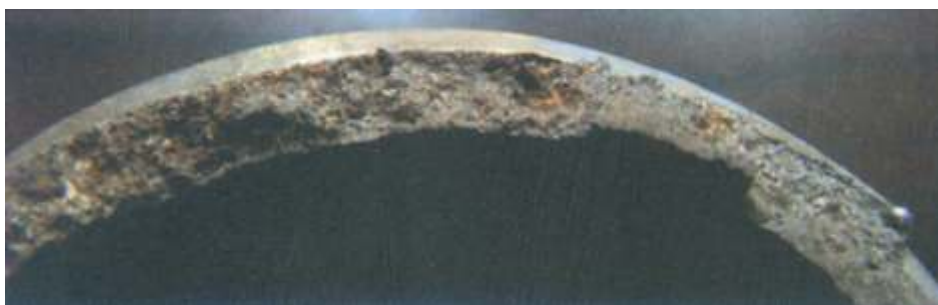
Fig. 8-5. Shrinkage porosity in red brass is caused by poor solidification (low pouring temperature, inadequate feeding).

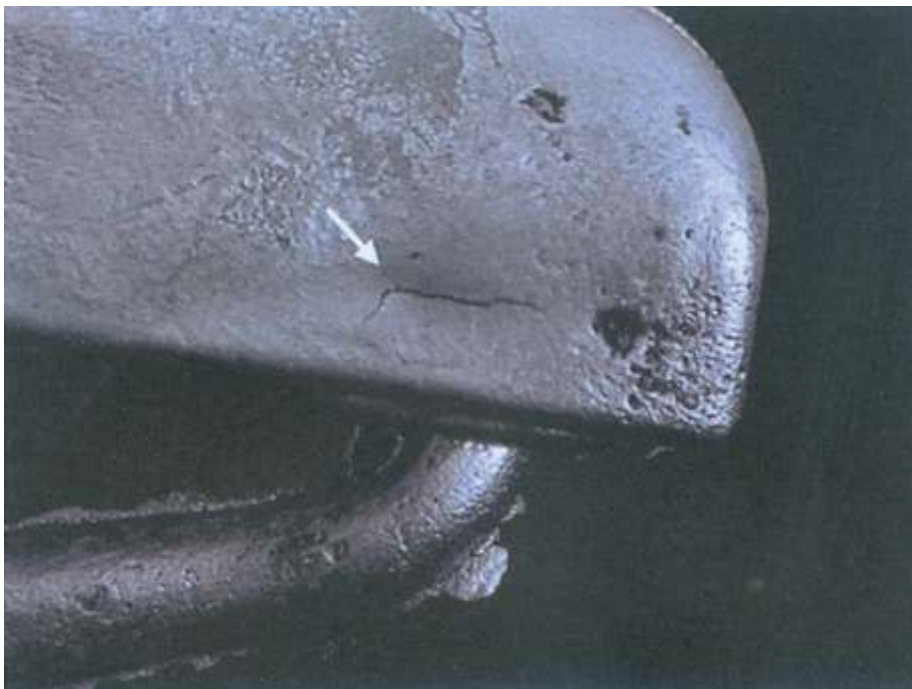
Fig. 8-6. Sink and shrinkage crack in permanent mold cast gunmetal resulted from the temperature being too low and form mold coating erosion: (a) crack in casting; (b) defect magnified.

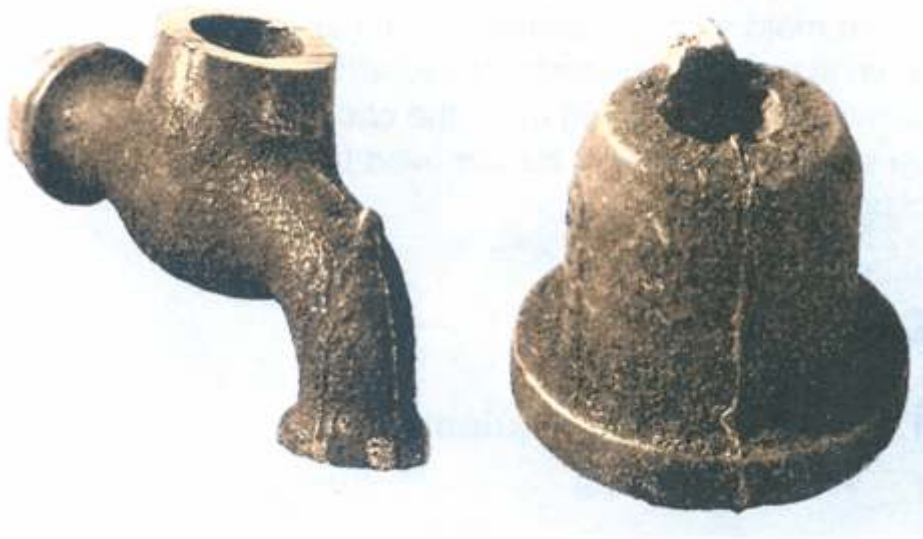
Fig. 9-1. A bronze alloy in green sand exhibits burn-on.

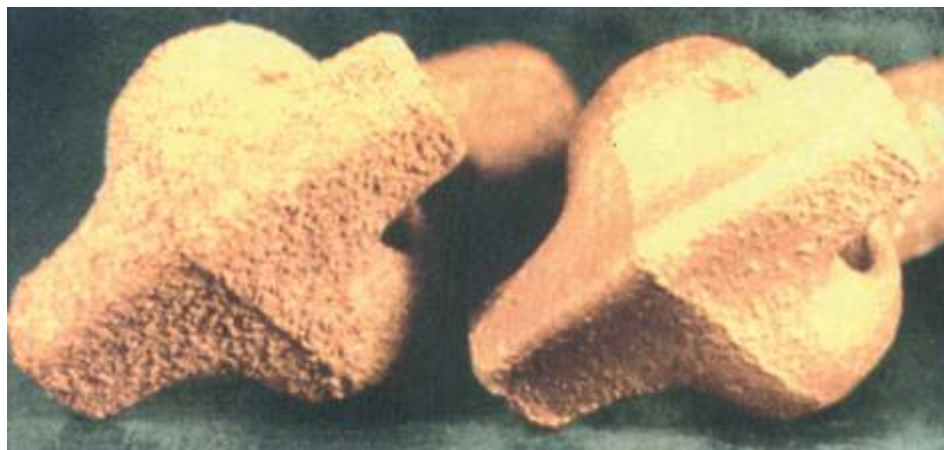
Fig. 9-4. The casting shows a burn in or metal penetration caused by improper sand mixture, excessive metal fluidity, and pouring temperature.

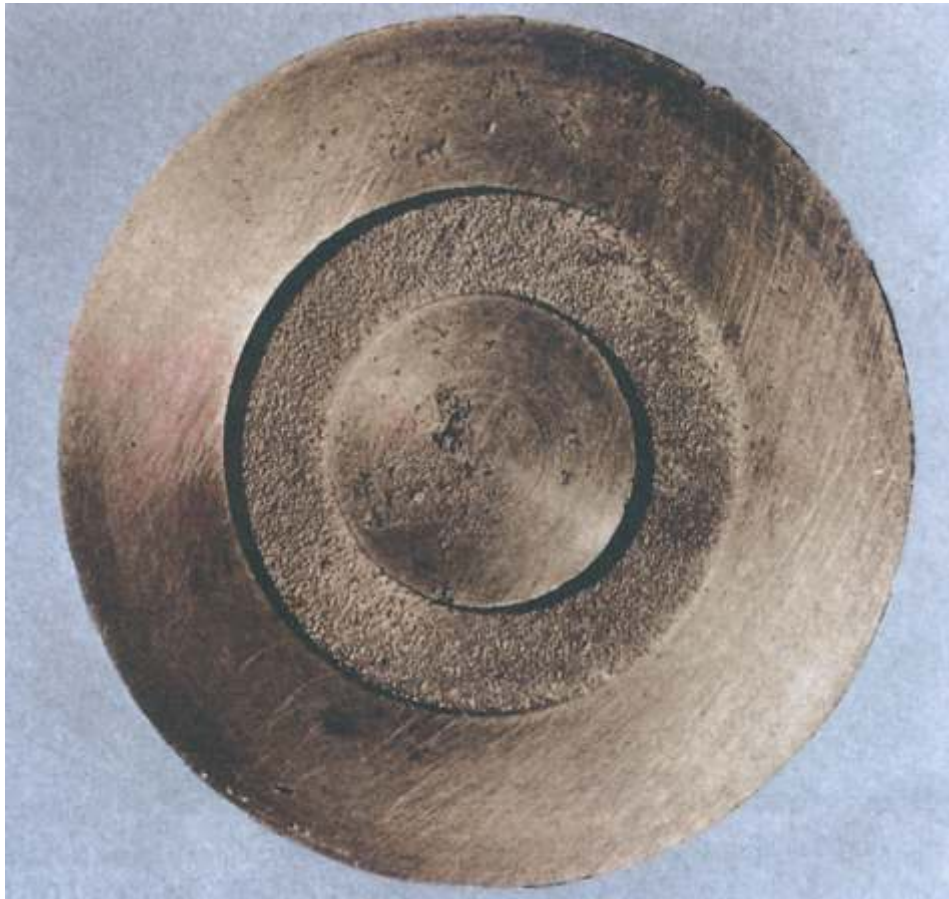
Fig. 10-1. Brass casting contains dross inclusions.

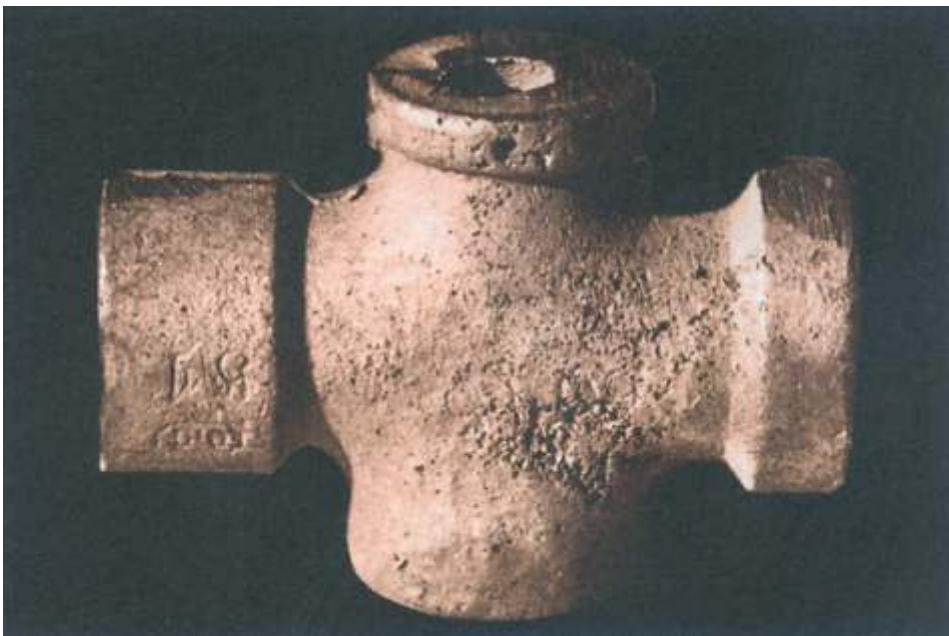
Fig. 10-2. Bronze valve body cast in green sand shows sand inclusions caused by core erosion.

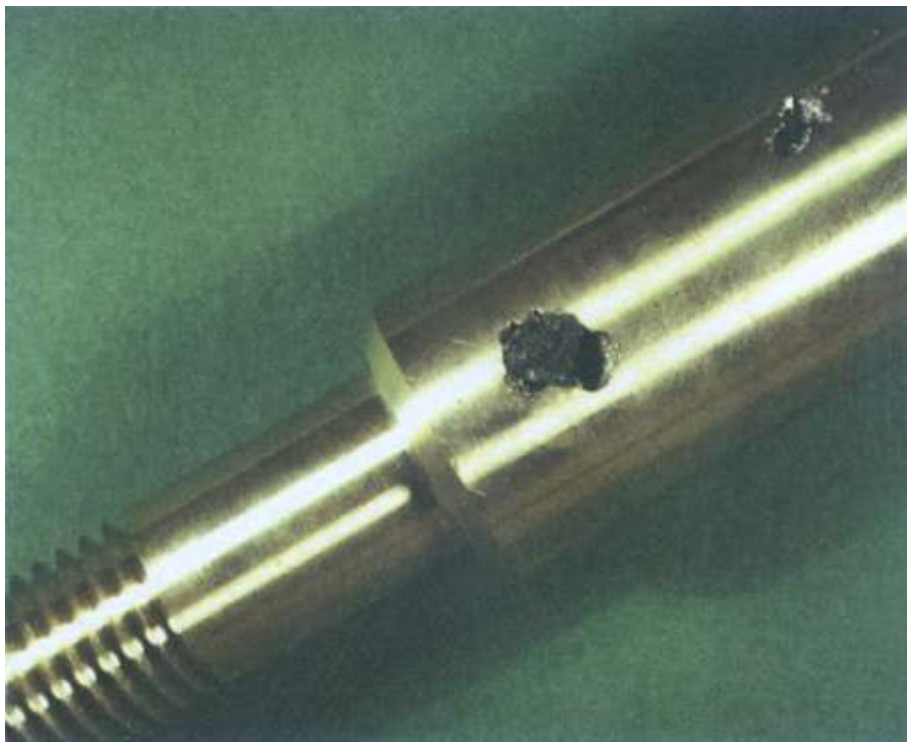
Fig. 10-6. A macro-inclusion in brass casting is a possible refractory vessel erosion.

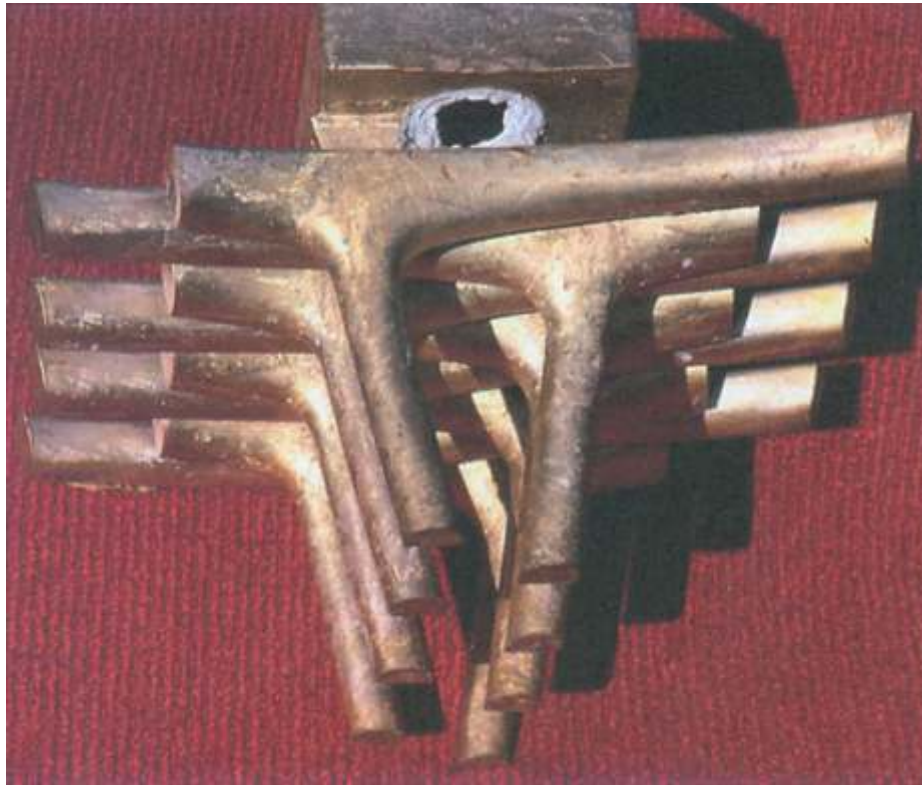
Fig. 10-7. Poor surface on aluminum bronze casting is due to excessive dross formation and lack of removal prior to pouring.

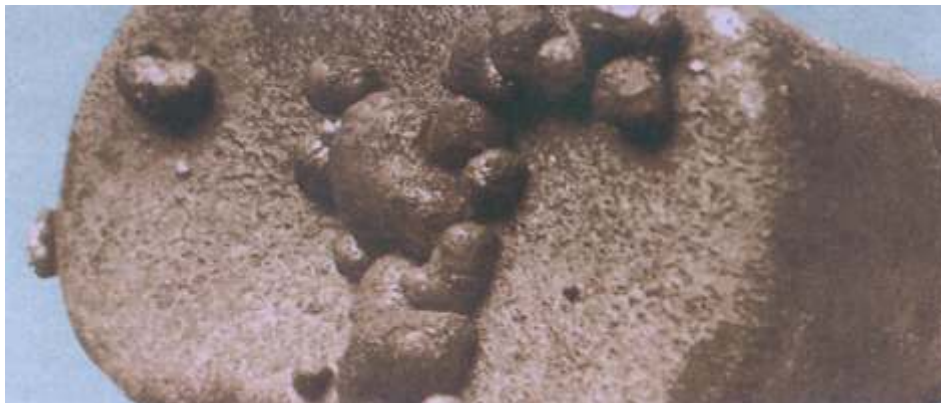
Fig. 11-1. Leaded tin bronze cast in green sand. Sprue exhibits tin sweat.

Another defect which can occur in copper alloy casting relates to low temperature metal alloy constituents (lead, tin), that segregate during latter stages of solidification and exude from the surface of the casting. Exudation of the residual liquid occurs due to forces of contraction and the pressure of released gas. This surface defect is often accompanied by microporosity. An example is tin sweat.

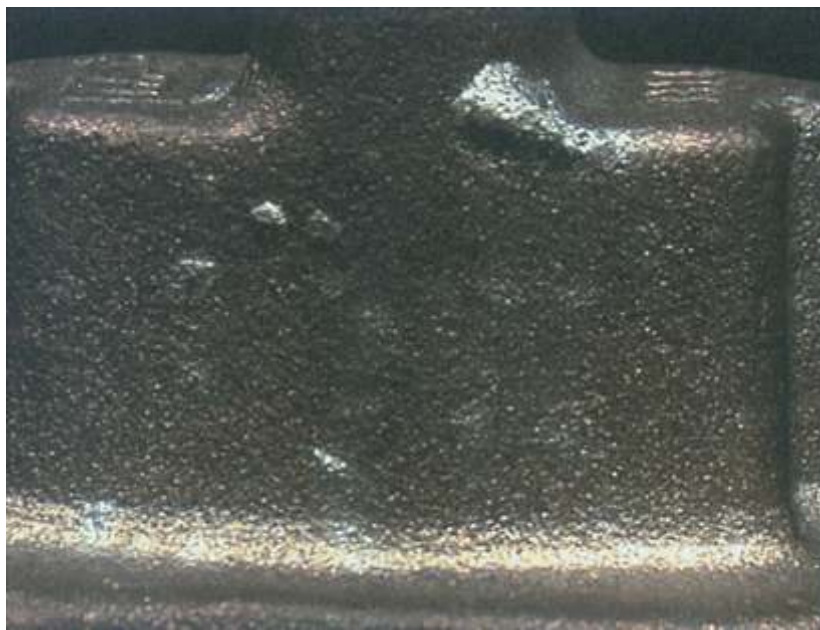
Fig. 11-3. Red brass exhibits tin sweat, caused by long solidification and gas evolution. Proper degassing and directional solidification are remedies.
