COPPER BASE ALLOYS

CASTING DEFECTS

COPPER BASE ALLOYS CASTING DEFECTS

Editor: Assistant Prof. Dr. Hikmet ERBIYIK

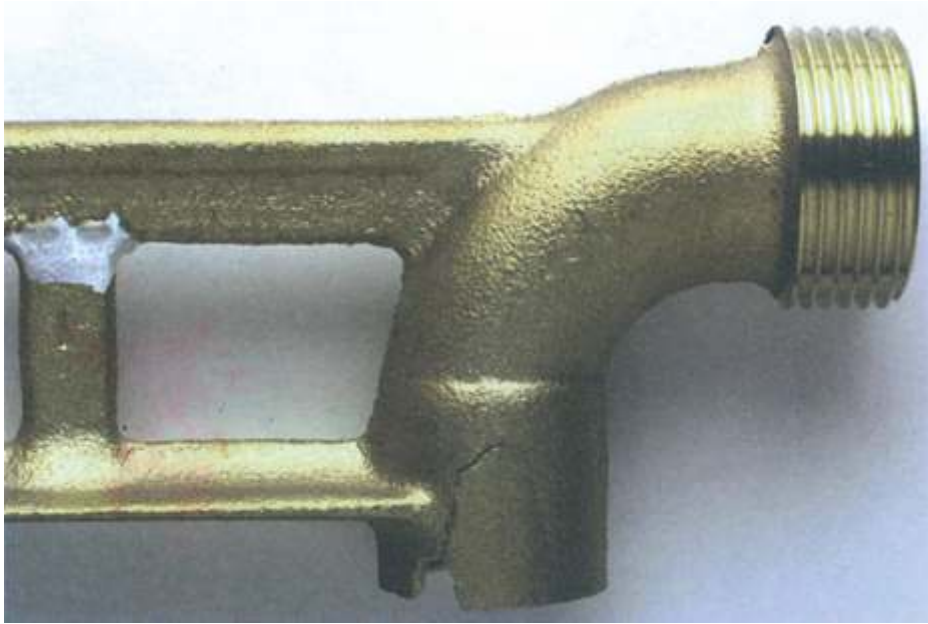
Fig. 11-4. Yellow brass casting crack, observed after machining, is possibly due to severe residual stress and/or temperature state during machining.

Cracked castings prior to service may arise from severe stress on the part due to machining. Any alloy segregation or inclusions may exacerbate this problem.

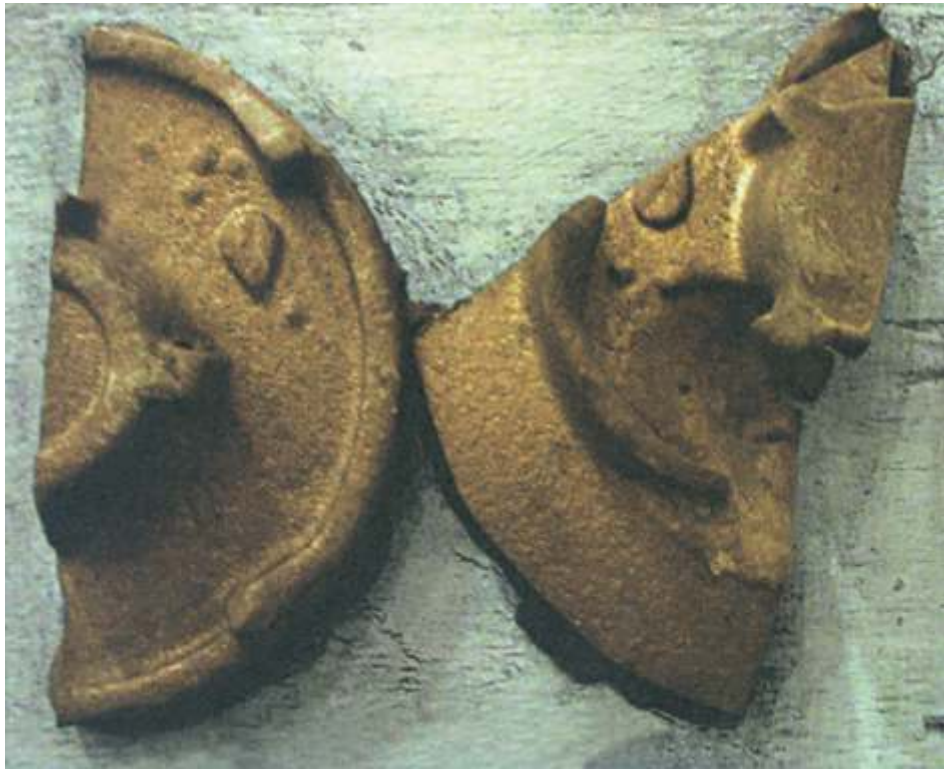
Fig. 11-6. Over blast damage on brass casting is due to excessive shot or grit casting cleaning.

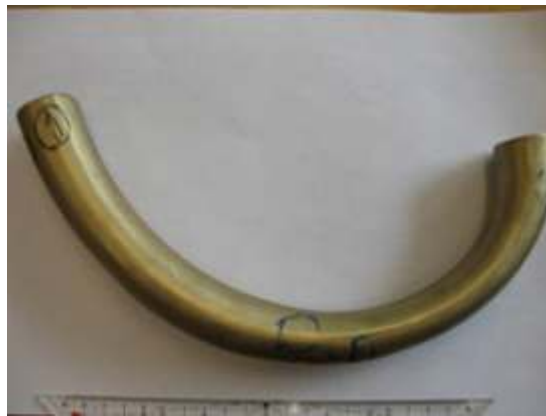
Fig. 12-1. Object 1, exhibiting surface cracks and a surface bulge at the location indicated by the circle at the right border of the image.

A pipe-shape part (Fig. 12-1) with cracks at the surface (Fig. 12-2) and at one location an irregular bulge of the surface (Fig. 12-3).

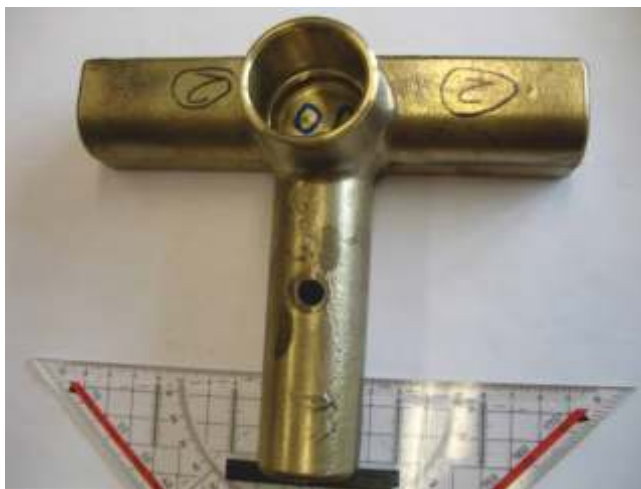
Fig. 12-4. Object 2 (body of a drain valve). At the bottom of the large bore in the center of the cast body, two defect areas were detected.

The body of a drain valve with a bore (Fig. 12-4). At the ground of the bore (Fig. 12-5), at one location a blue coloured surface contamination is visible (Fig. 12-6). At a different location, fine surface cracks are visible (Fig. 12-7).

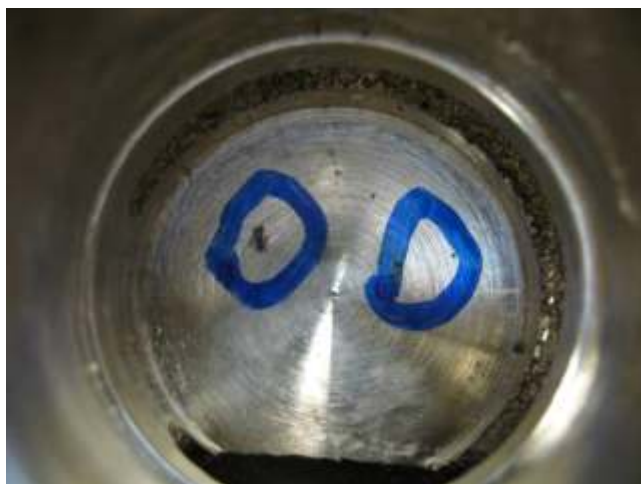
Fig. 12-5. Defect areas at the bottom of the large bore.

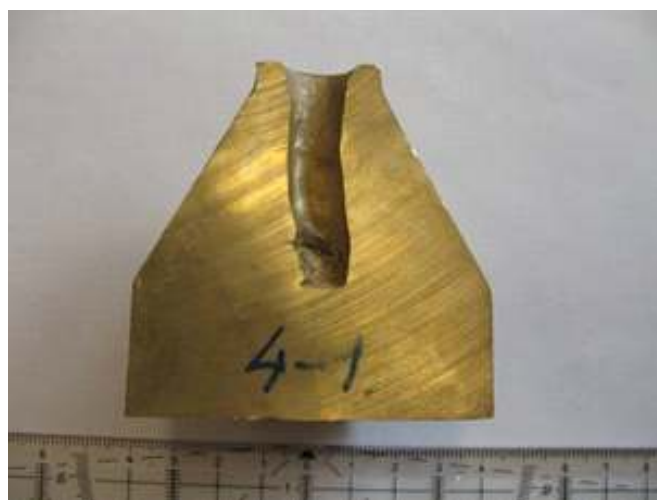
Fig.12-8. Object 3, a cone-shape casting with a blind hole at the center.

A cone-shaped part with a blind hole in the center (Fig. 12-8). The inner surface of the hole exhibits defective areas (Fig. 12-9).

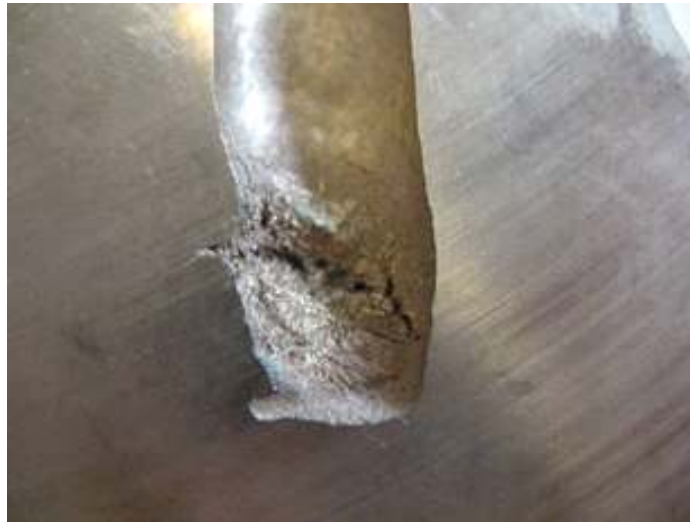
Fig.12-9. Defect area inside the blind hole.

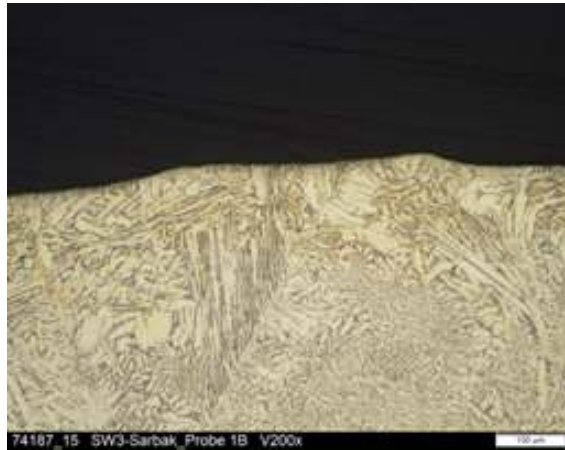
Fig.12-13. Target cross section through the surface bulge at Object 1.

A metallographic target section through the surface bulge (Fig. 12-13) does not show any irregularities concerning the microstructure, so that the surface bulge might be related to a defect of the casting mould. This can, however, not be verified by the present investigation.

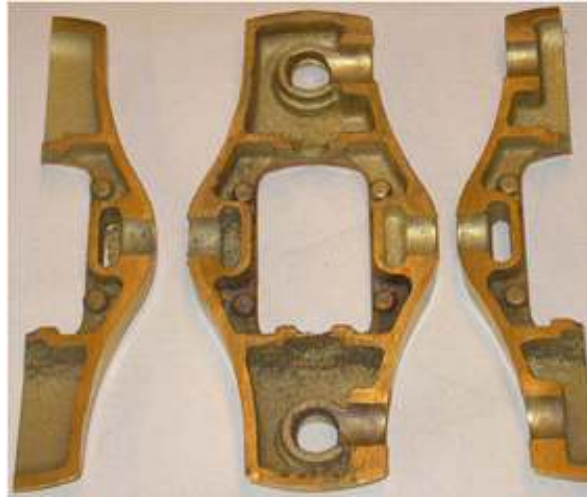
Fig. 13-2. Example of the cutting of the last casting in each sequence.

Each casting in the sequence was marked by scraping on the large sand core an individual identification mark of the sequence. Then the sequence of each casting could be determined even after grinding and polishing it from outside. After cutting off the gating system and risers at castings where sent to laboratory. Only the right hand side castings were polished while the left hand side castings were left as-cast. An exception was the last casting of each sequence, which was cut to halves along the parting line. After that the upper part of casting was cut again to two halves in opposite direction, normal to the parting line as shown in Fig. 13-2.

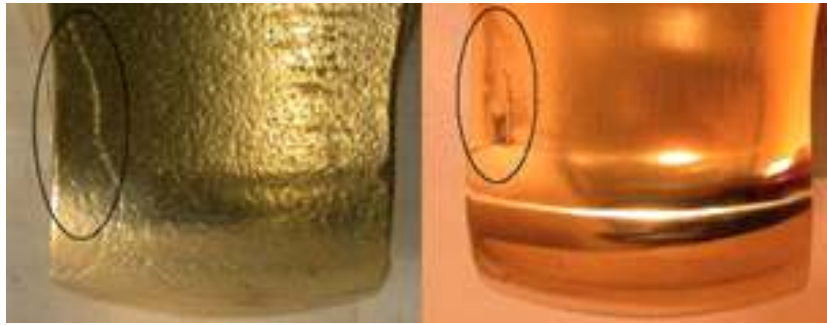
Fig. 13-4. A graphite wake type surface defect before and after grinding.

At first the as-cast surfaces were visually inspected and the types of defects were classified according to the categories shown below. An example of a graphite wake defect before and after grinding is shown in Fig. 13-4.:
